SS Mary & Patrick's Church, Avoca, Co Wicklow

For: Avoca Parish
Date: August 2023
Job Ref: 18-32
Issue Date: Sep 2023

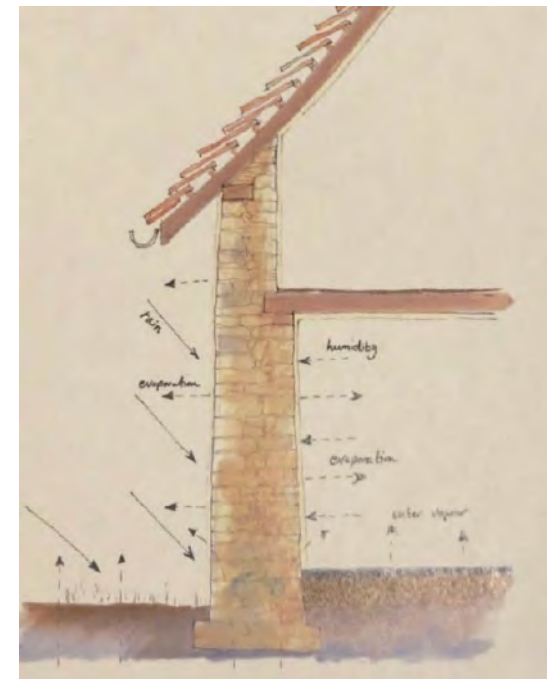
Fig 3: Traditional Building Construction: lime plaster inside, lime pointing, lower ground level outside, wall gets wet & dries out constantly. Earth outside absorbs the runoff, and it is much lower than the inside floor.

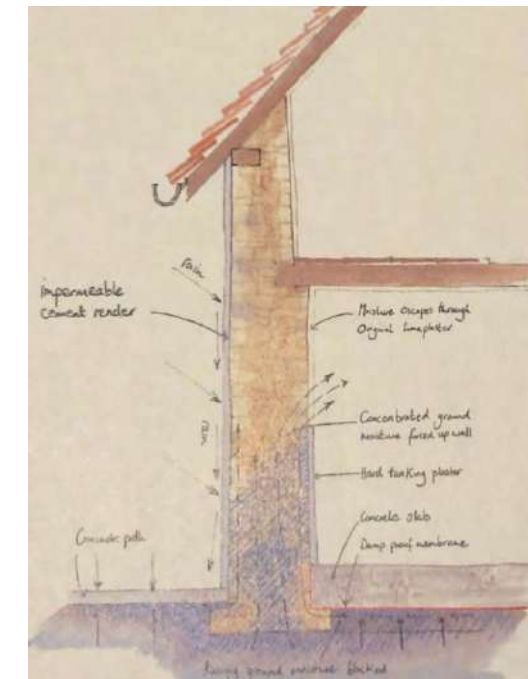
Fig 4: Impact of modern materials on Traditional Construction: impermeable pointing outside, hard ground outside, hard plaster inside (in part), wall is saturated and cannot dry out. Excess moisture in wall evaporates through the soft part only, the remaining lime plaster.

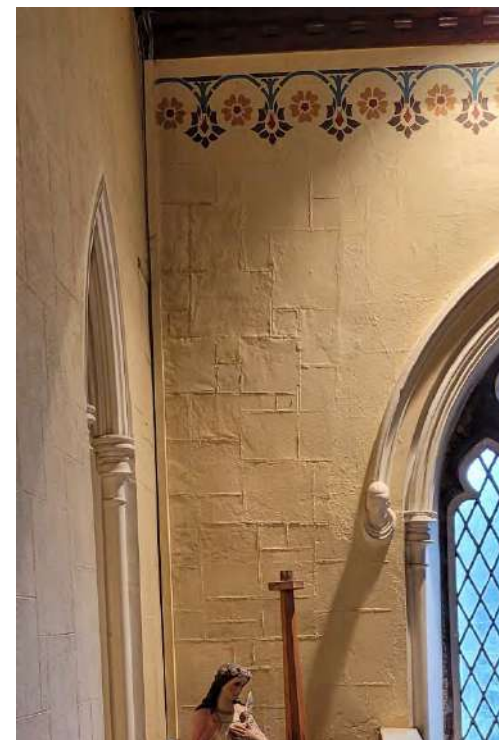
Fig 7: Internal Wall finish with random ashlar pattern and decorative stencilling

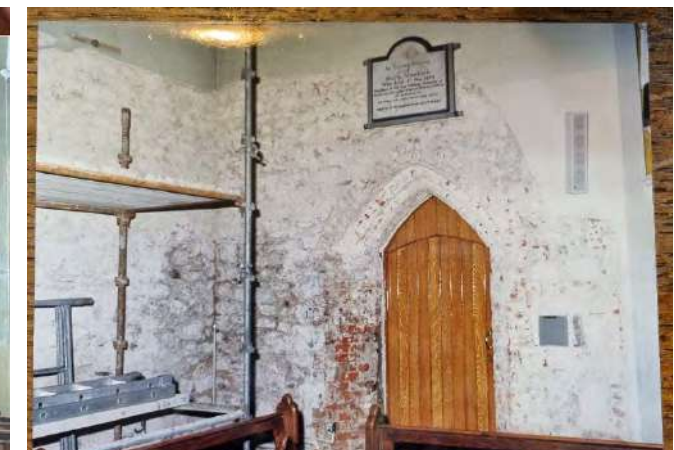
Fig 15: Internal photo of Avoca Church, internal plaster repair work to East Transept, assumed 2000, provided by Fr Michal Murphy P.P.

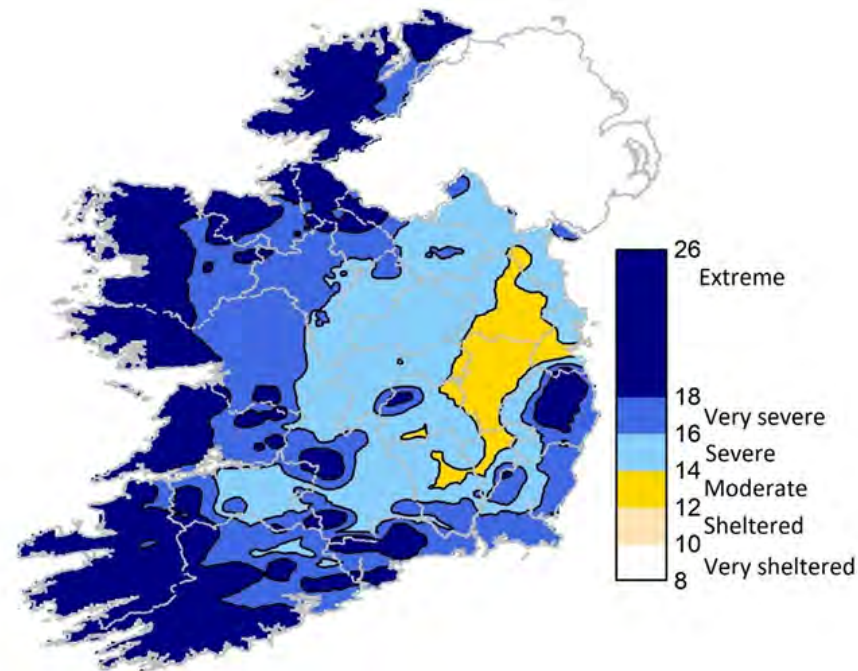
Figure 9: Map airfield index (m_A) for the period 1991 – 2020 for the Republic of Ireland. Suggested classes of exposures: very sheltered (<10), sheltered (10 – 12), moderate (12 – 14), severe (14 – 16), very severe (16 – 18) and extreme (18 – 26).

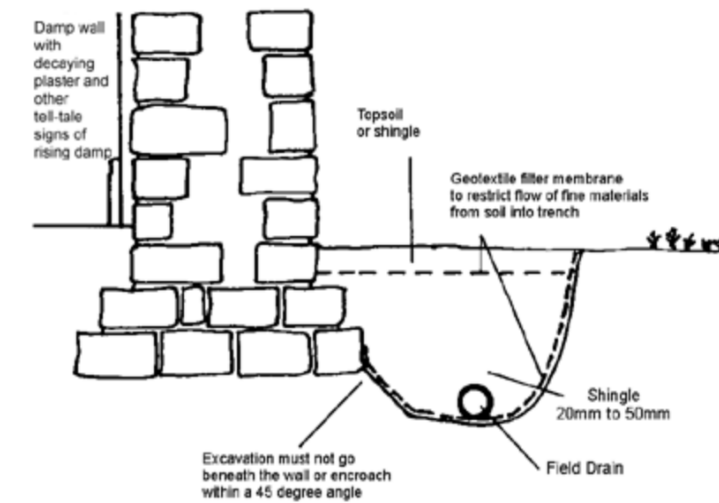
Fig 17: Sketch of French Drain proposal.

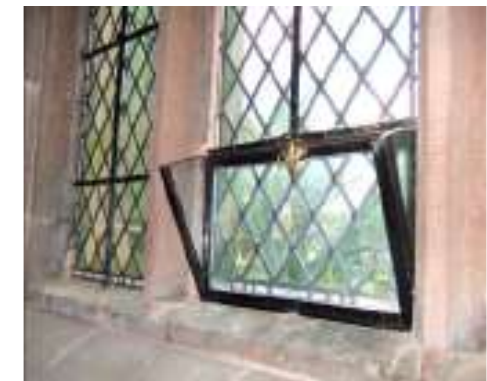
Fig 18: Proposal for modifying existing metal window

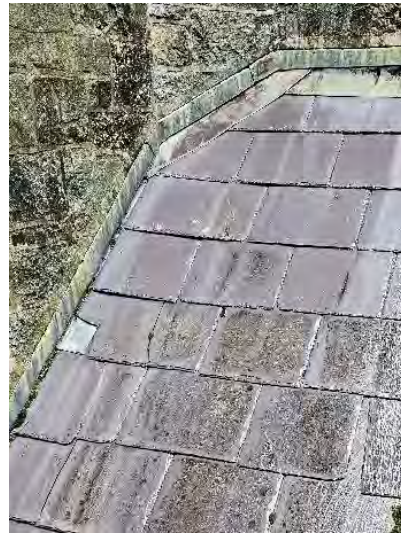
Fig 20: Existing lead flashing detail at low-level roof

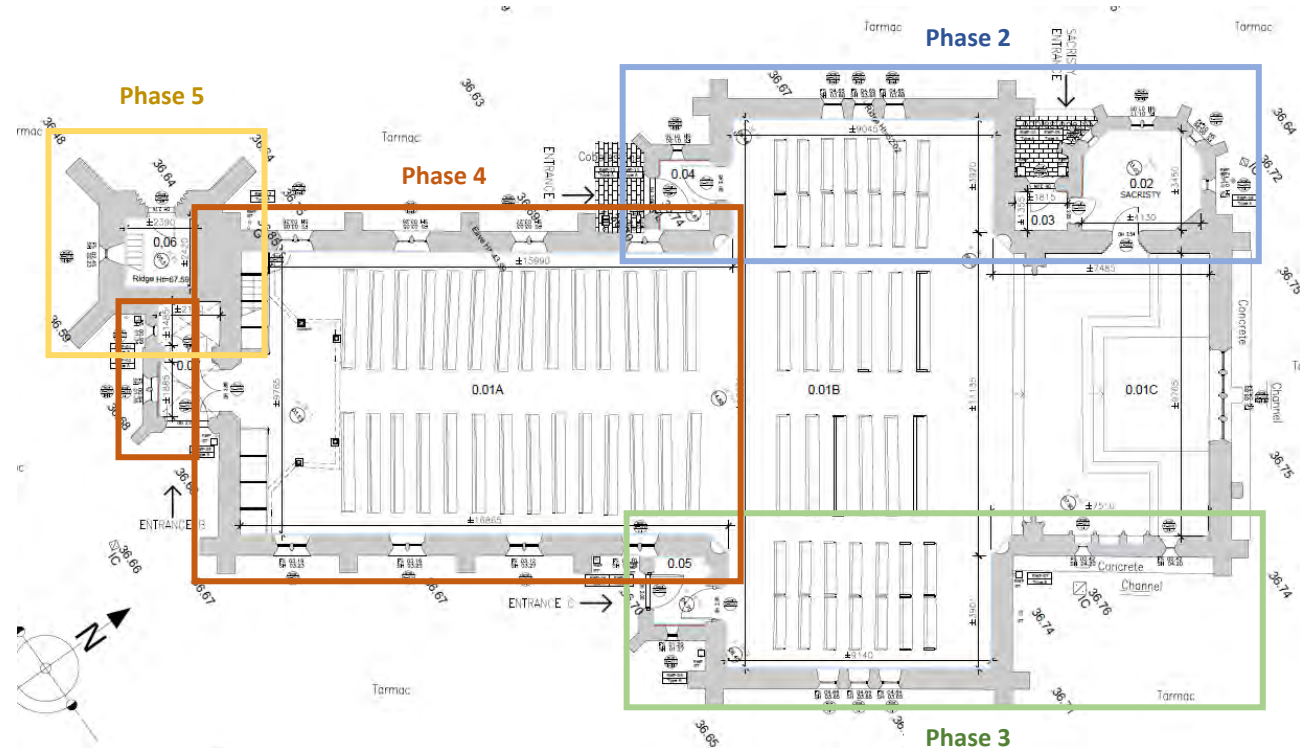
Fig 21: Plan of church identifying possible sequencing

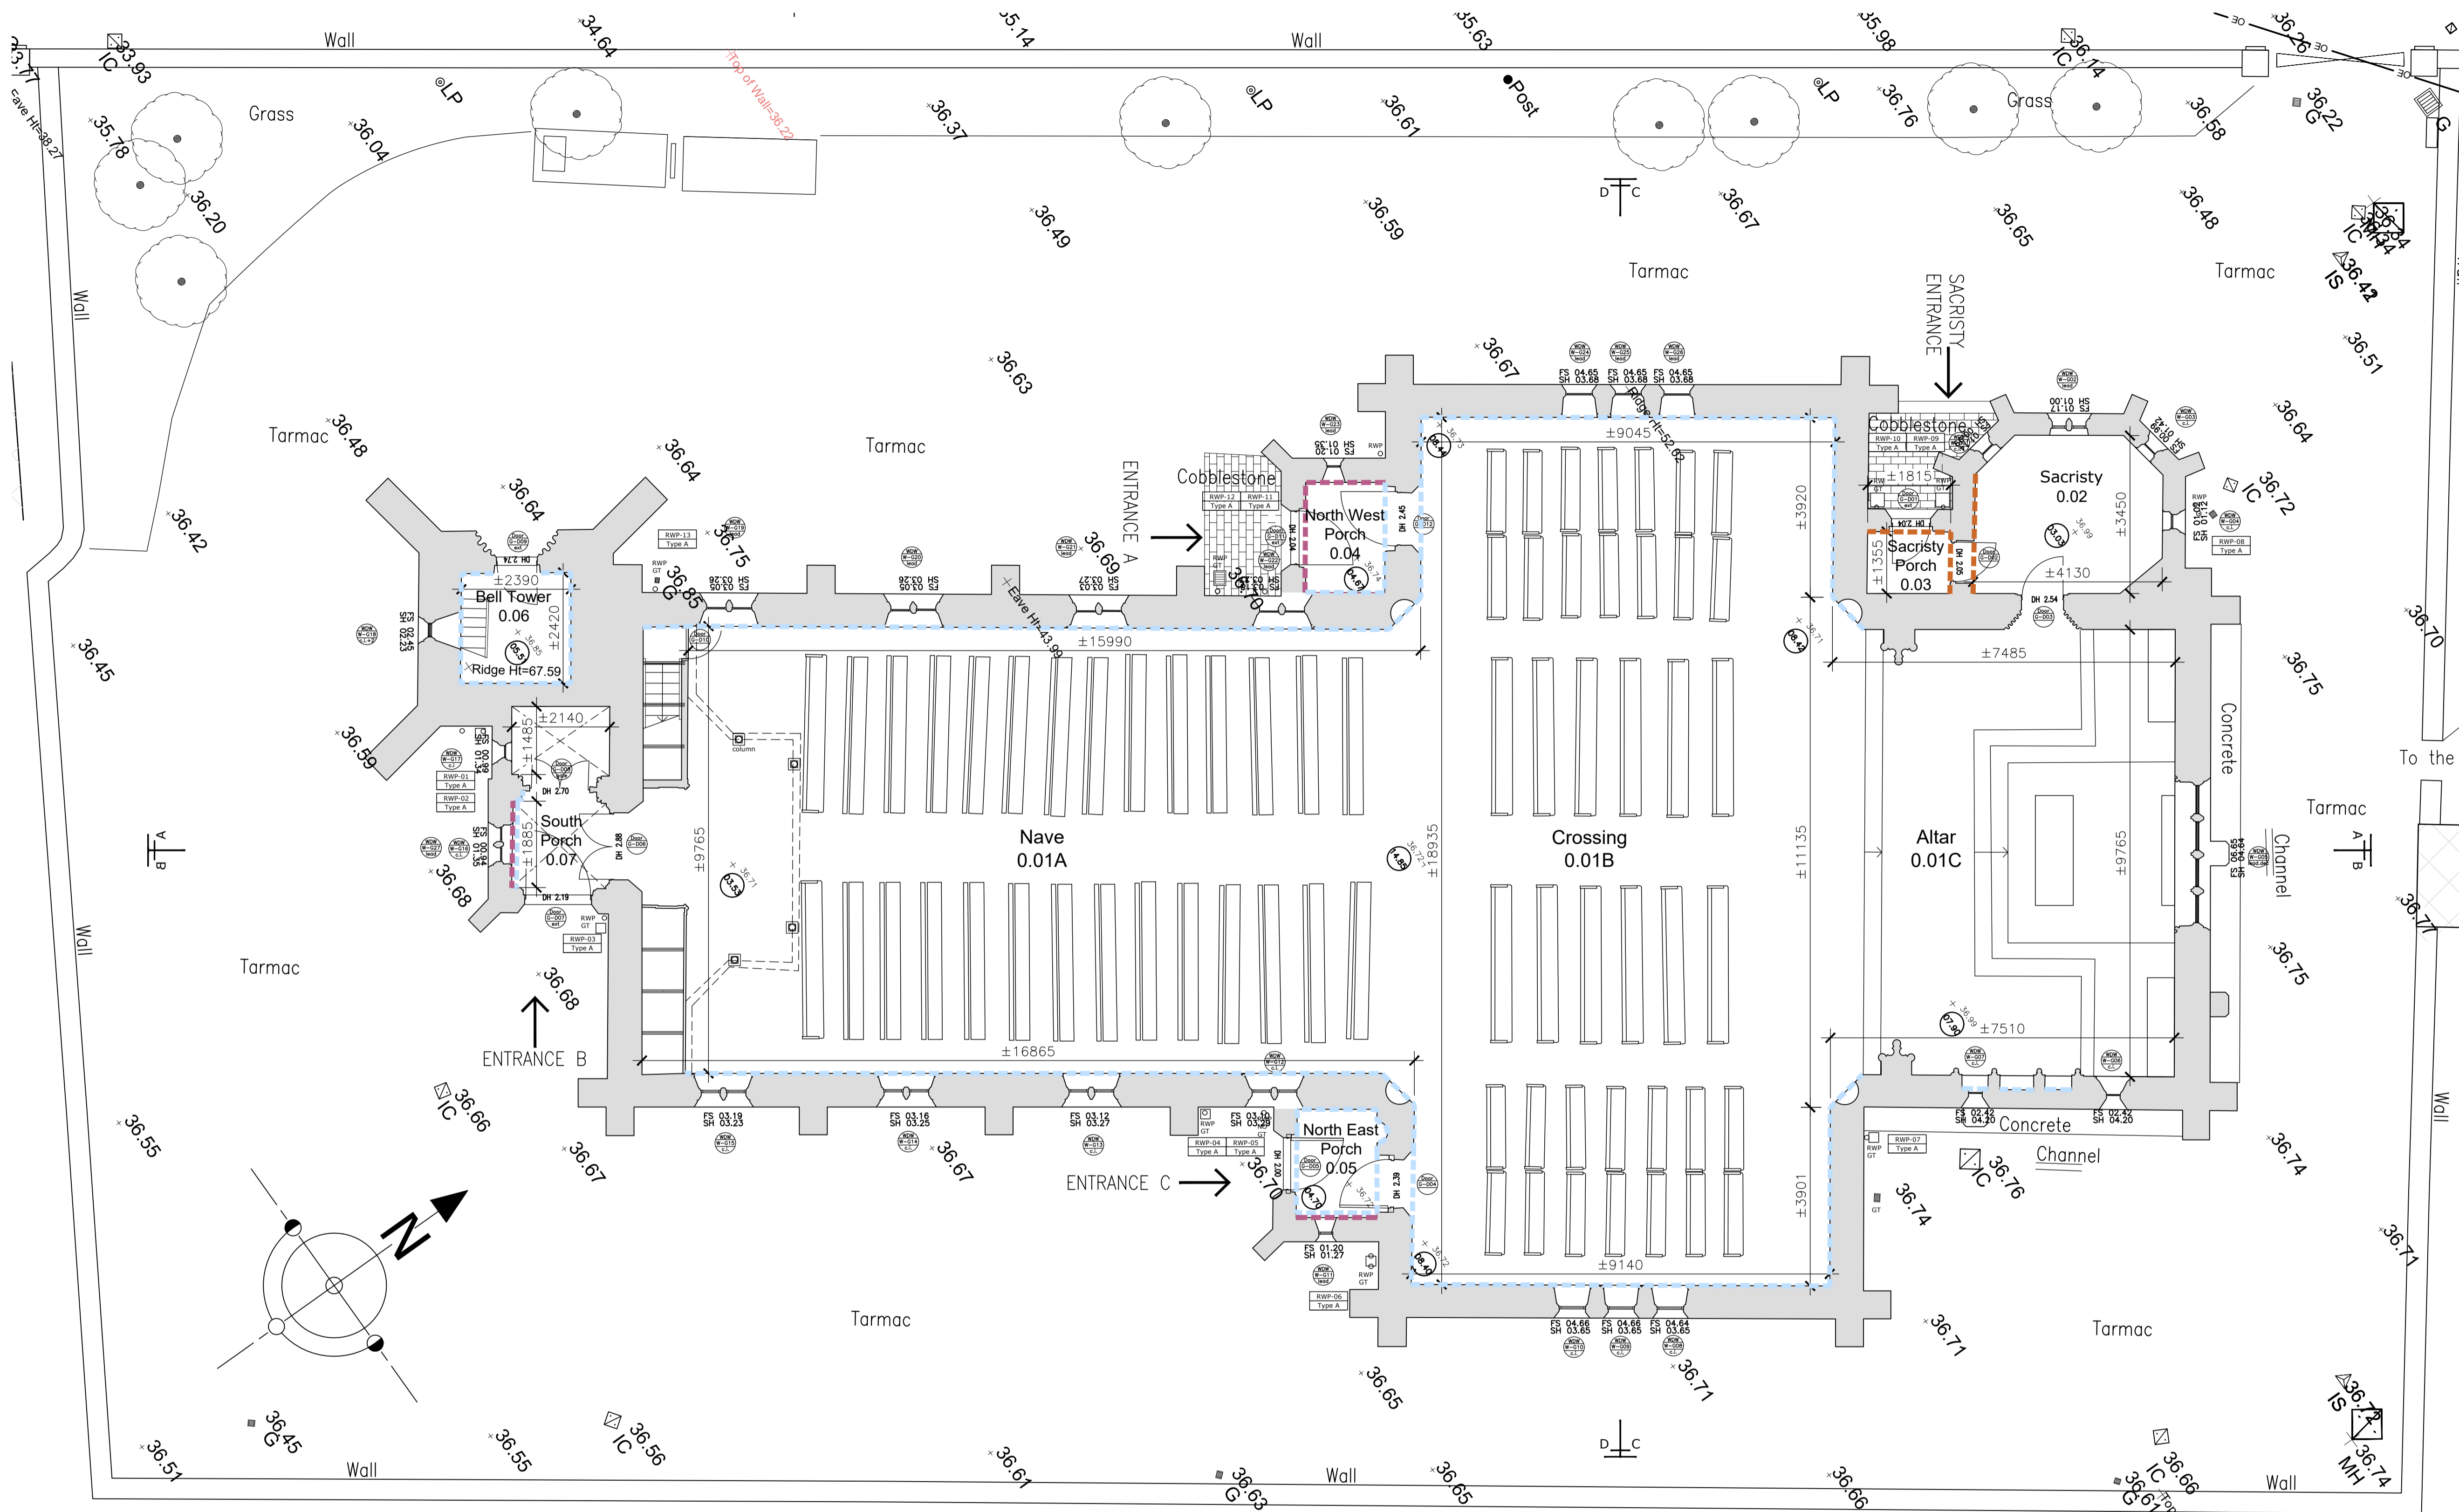
EXISTING GROUND FLOOR PLAN

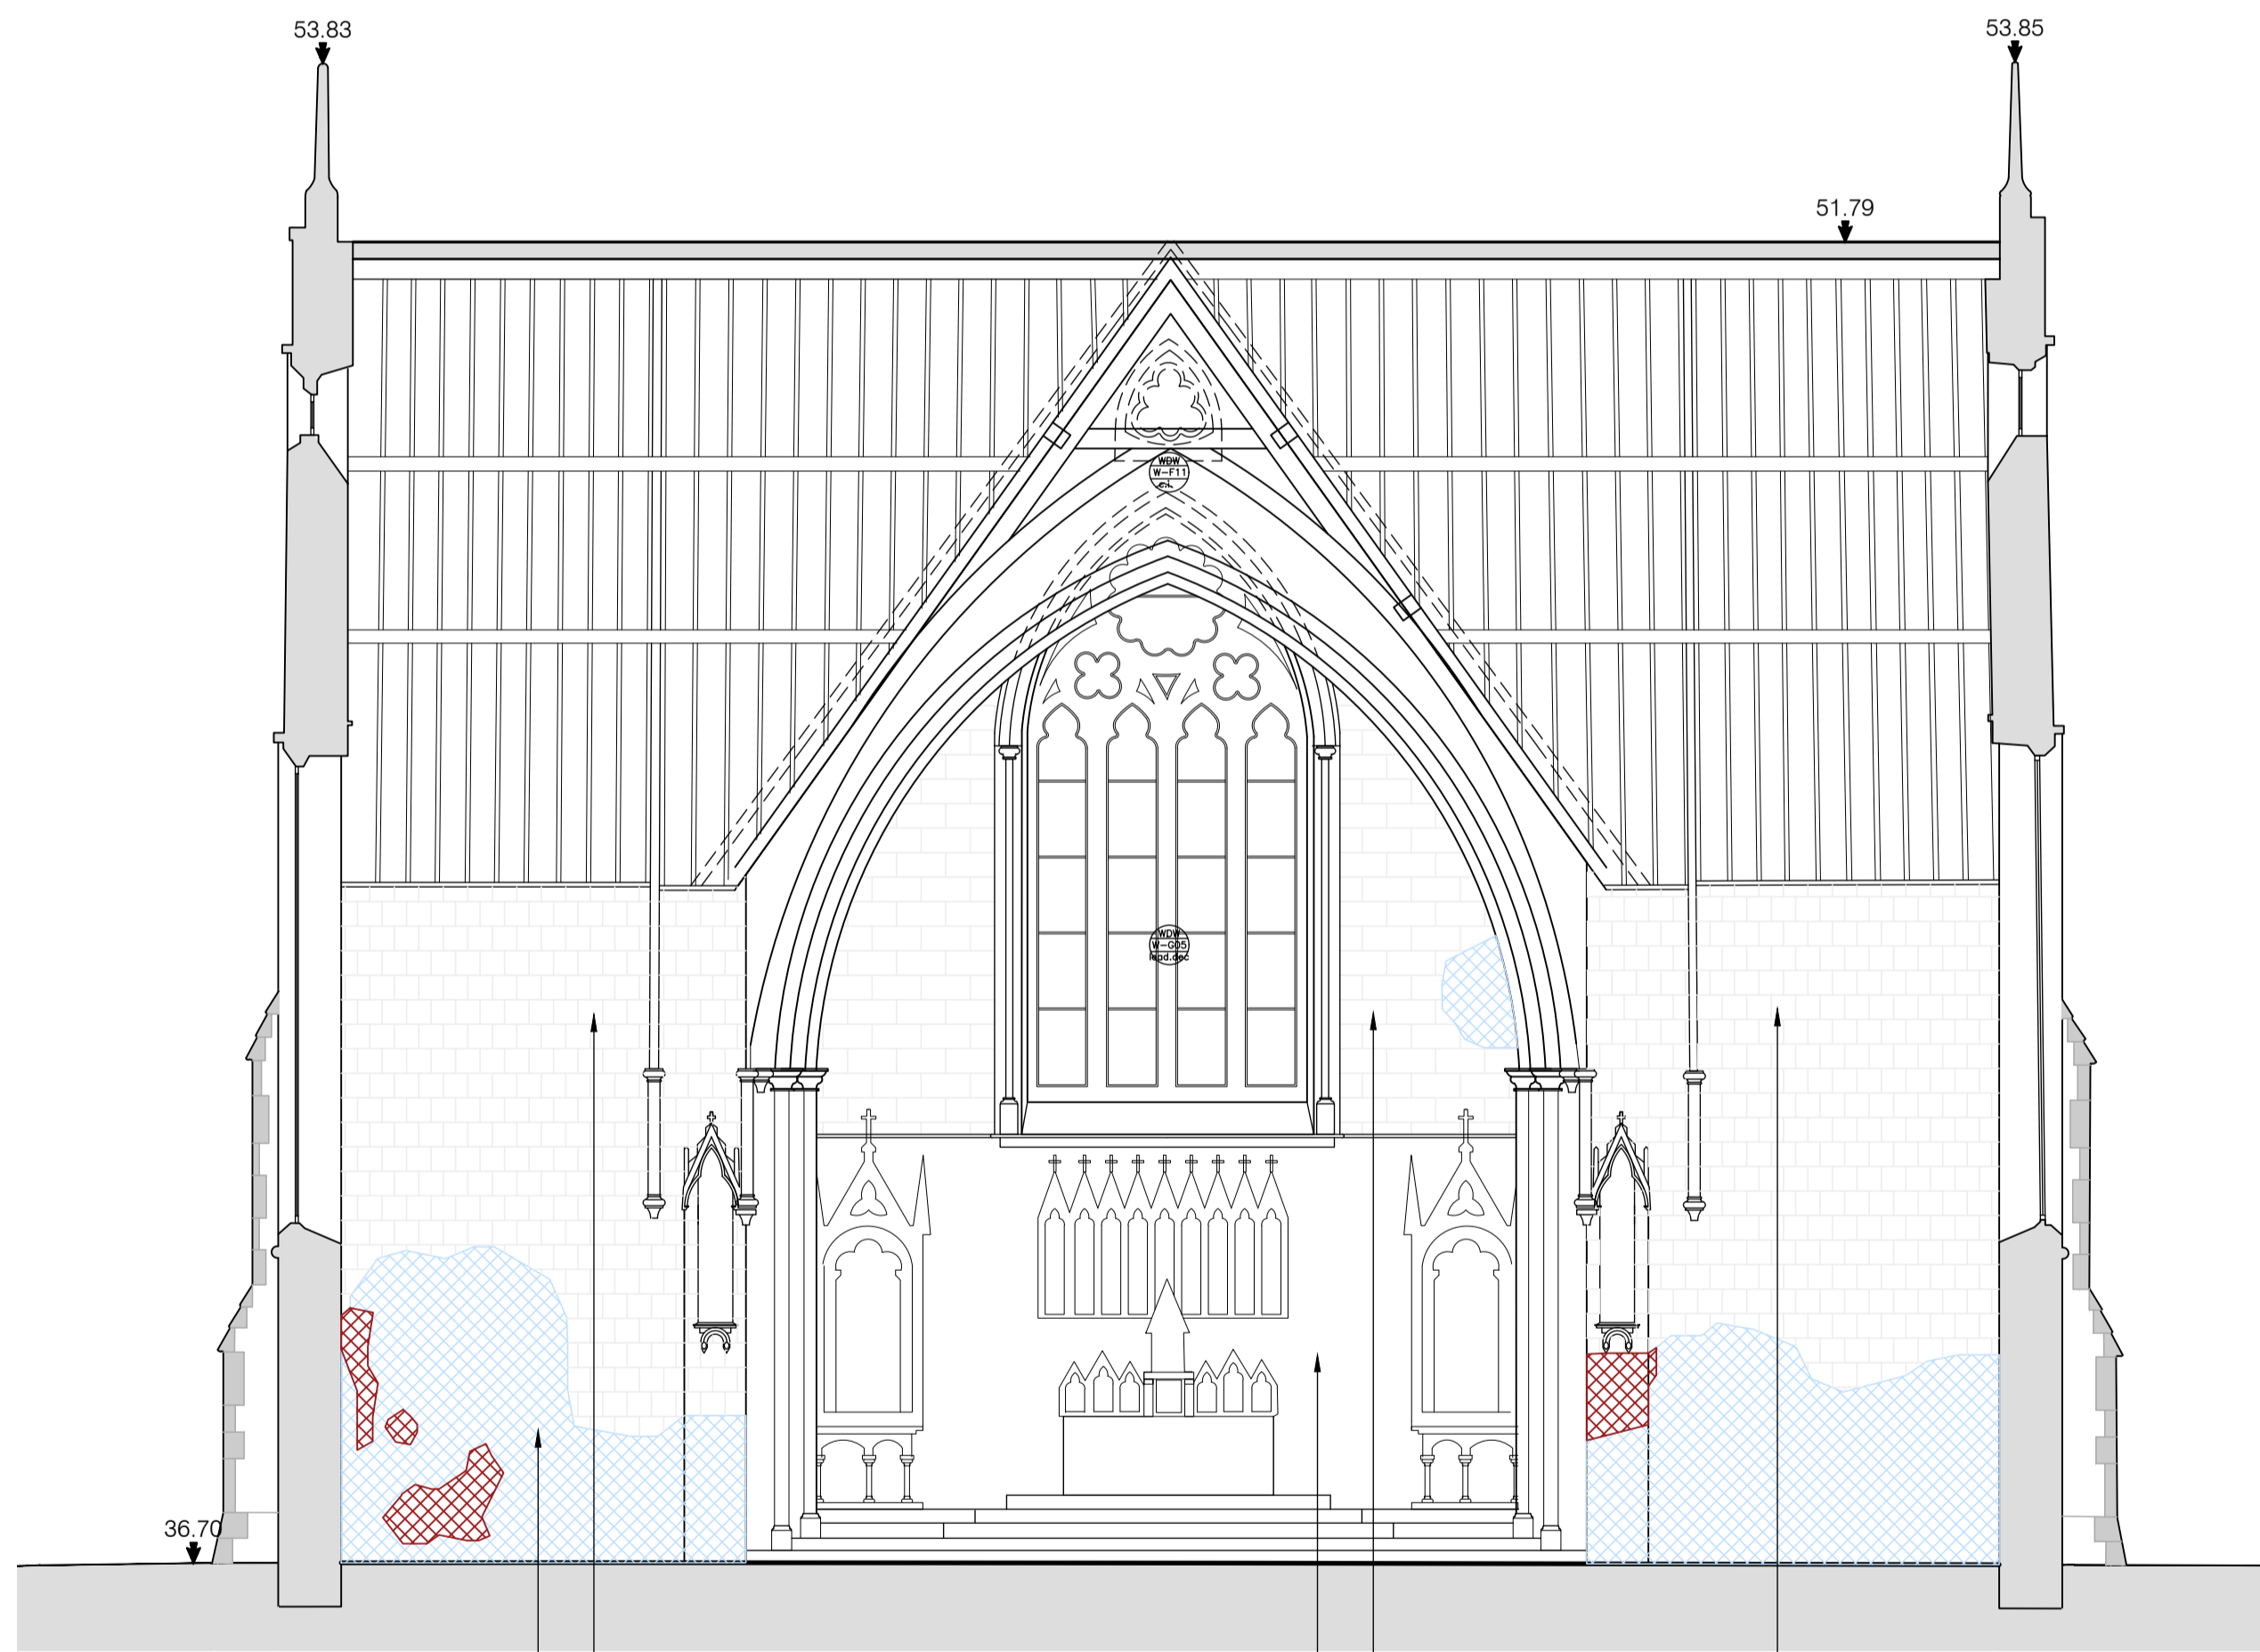
Transept walls finished with a 'random ashlar' pattern. Lower section to wall finished with 'flat smooth' pattern suggesting a more recent repair.

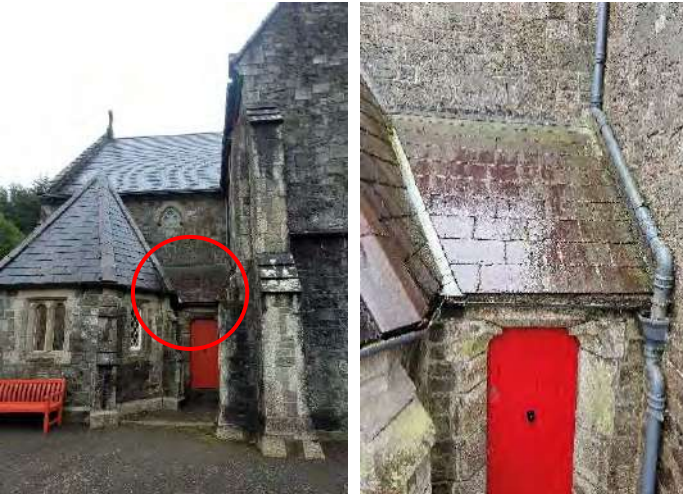
Entrance to sacristy. Note rainwater downpipe arrangement. Significant water ingress noted to the interior in this location due to failing roof covering and poor functioning rainwater goods.

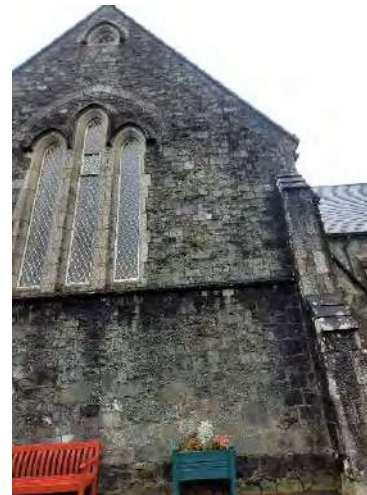
West transept; view right hand side. Heavy staining and cementitious pointing to stone throughout.

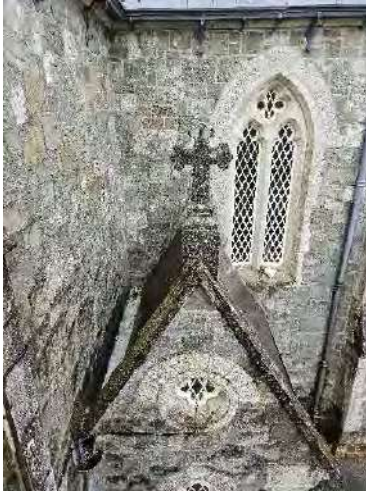
Valley gutter and roof B, pitch B2, to north west entrance porch. Gutter in poor condition corresponding with deteriorated fabric internally.

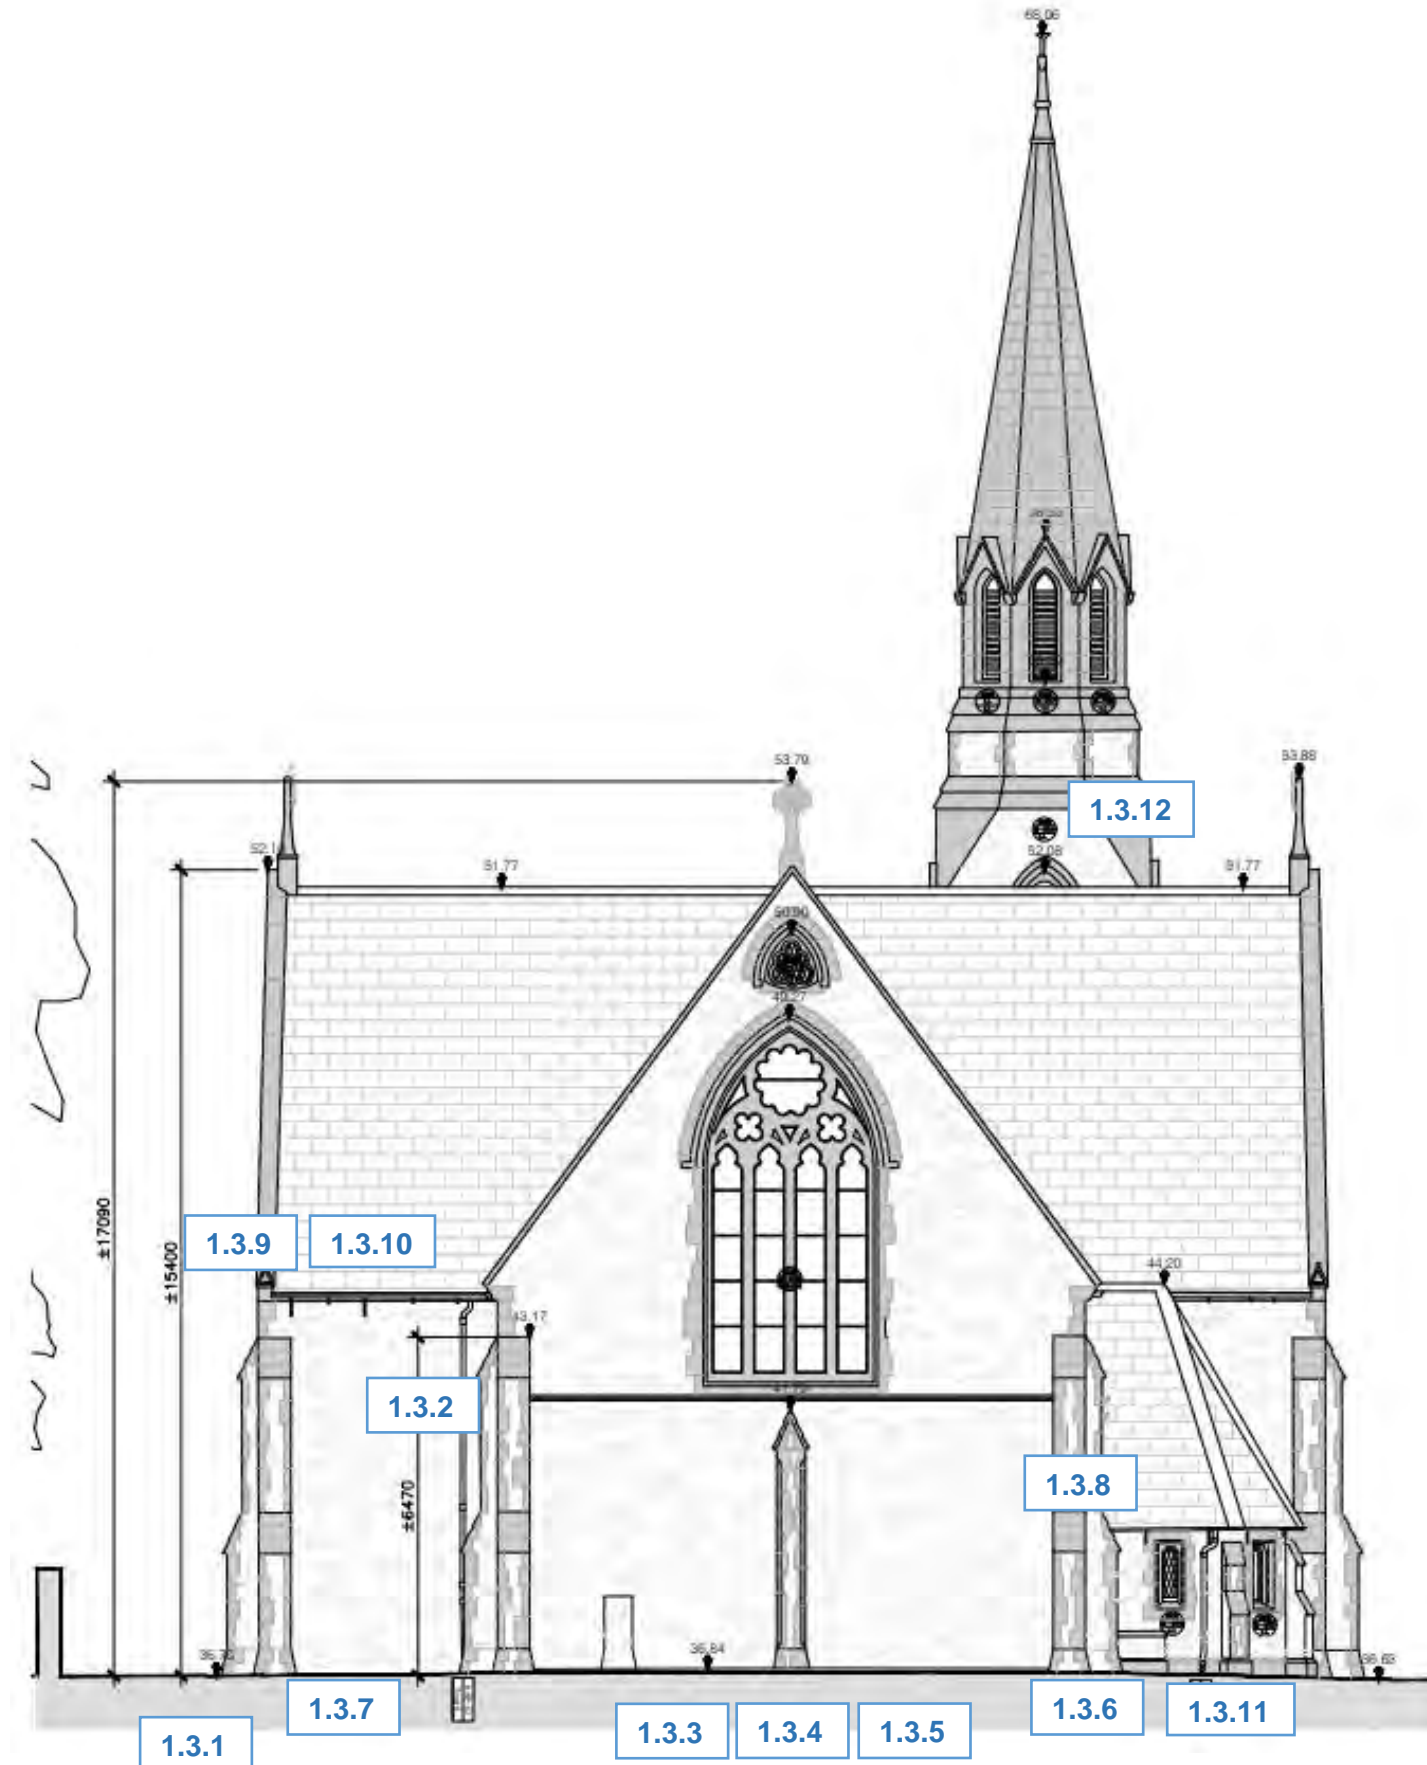
1.3 Existing North (Side) Elevation

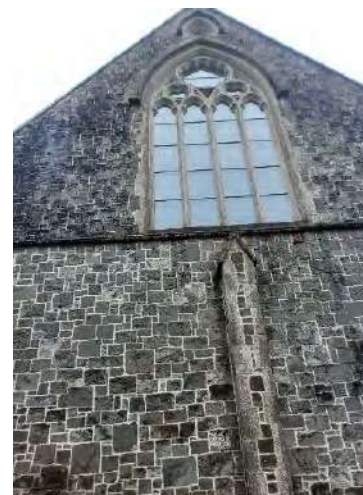
North elevation behind Altar: central. Façade re-pointed. Stained glass window with secondary storm glazing externally.

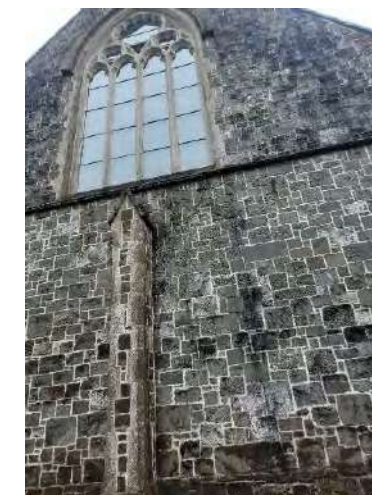
North elevation behind Altar: central. Façade re-pointed.

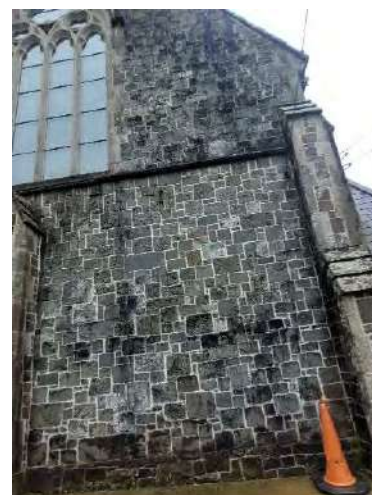
North elevation behind Altar: right hand side. Façade re-pointed. Staining at low level likely due to rising damp.

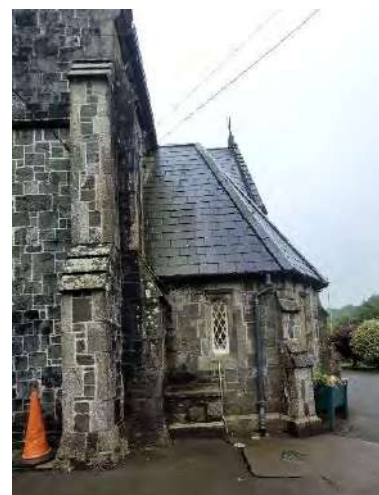
Sacristy, windows W-G04. Rainwater goods in this location are poor functioning.

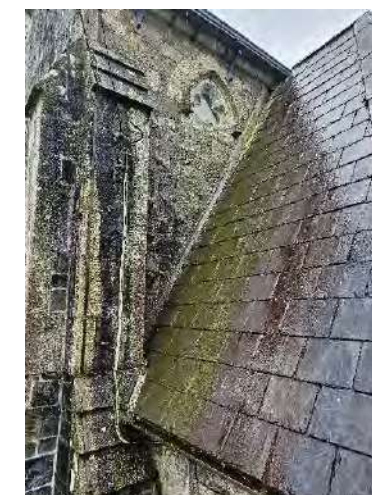
Algae growth to Roof D, pitch D5 along east wall. Staining to stone. Electrical incoming supply seen to buttress entering sacristy.

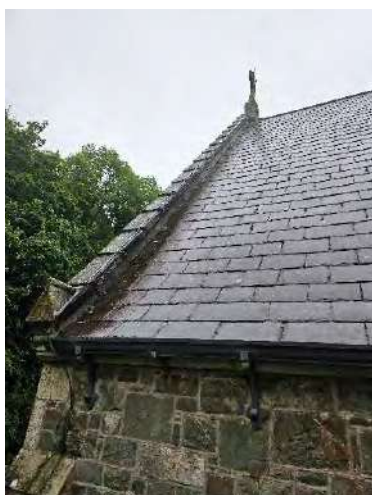
High level roof, north-east end. Slatework, cast iron gutter & brackets and capping detail to wall Roof A, pitch A7.

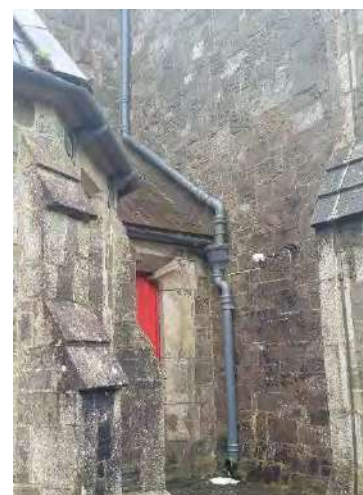
Rainwater pipe RWP-10 in poor condition with overflowing gully. North elevation along west transept with entrance door to sacristy.

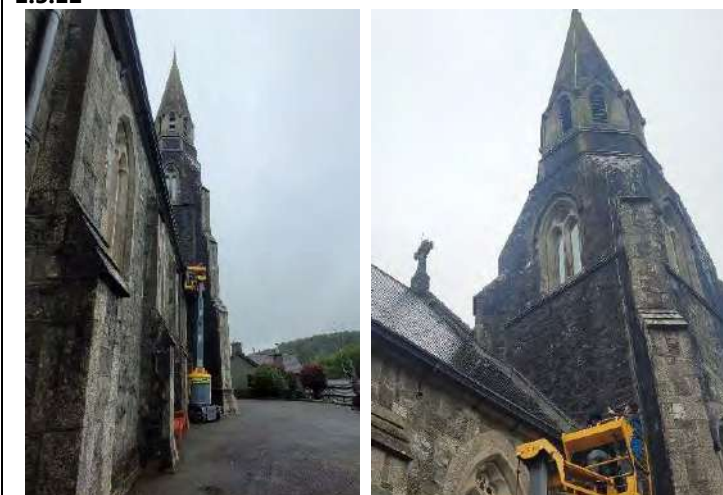
North elevation of the bell tower. Heavy staining and localised lime leaching to stone. Secondary storm glazing to windows.

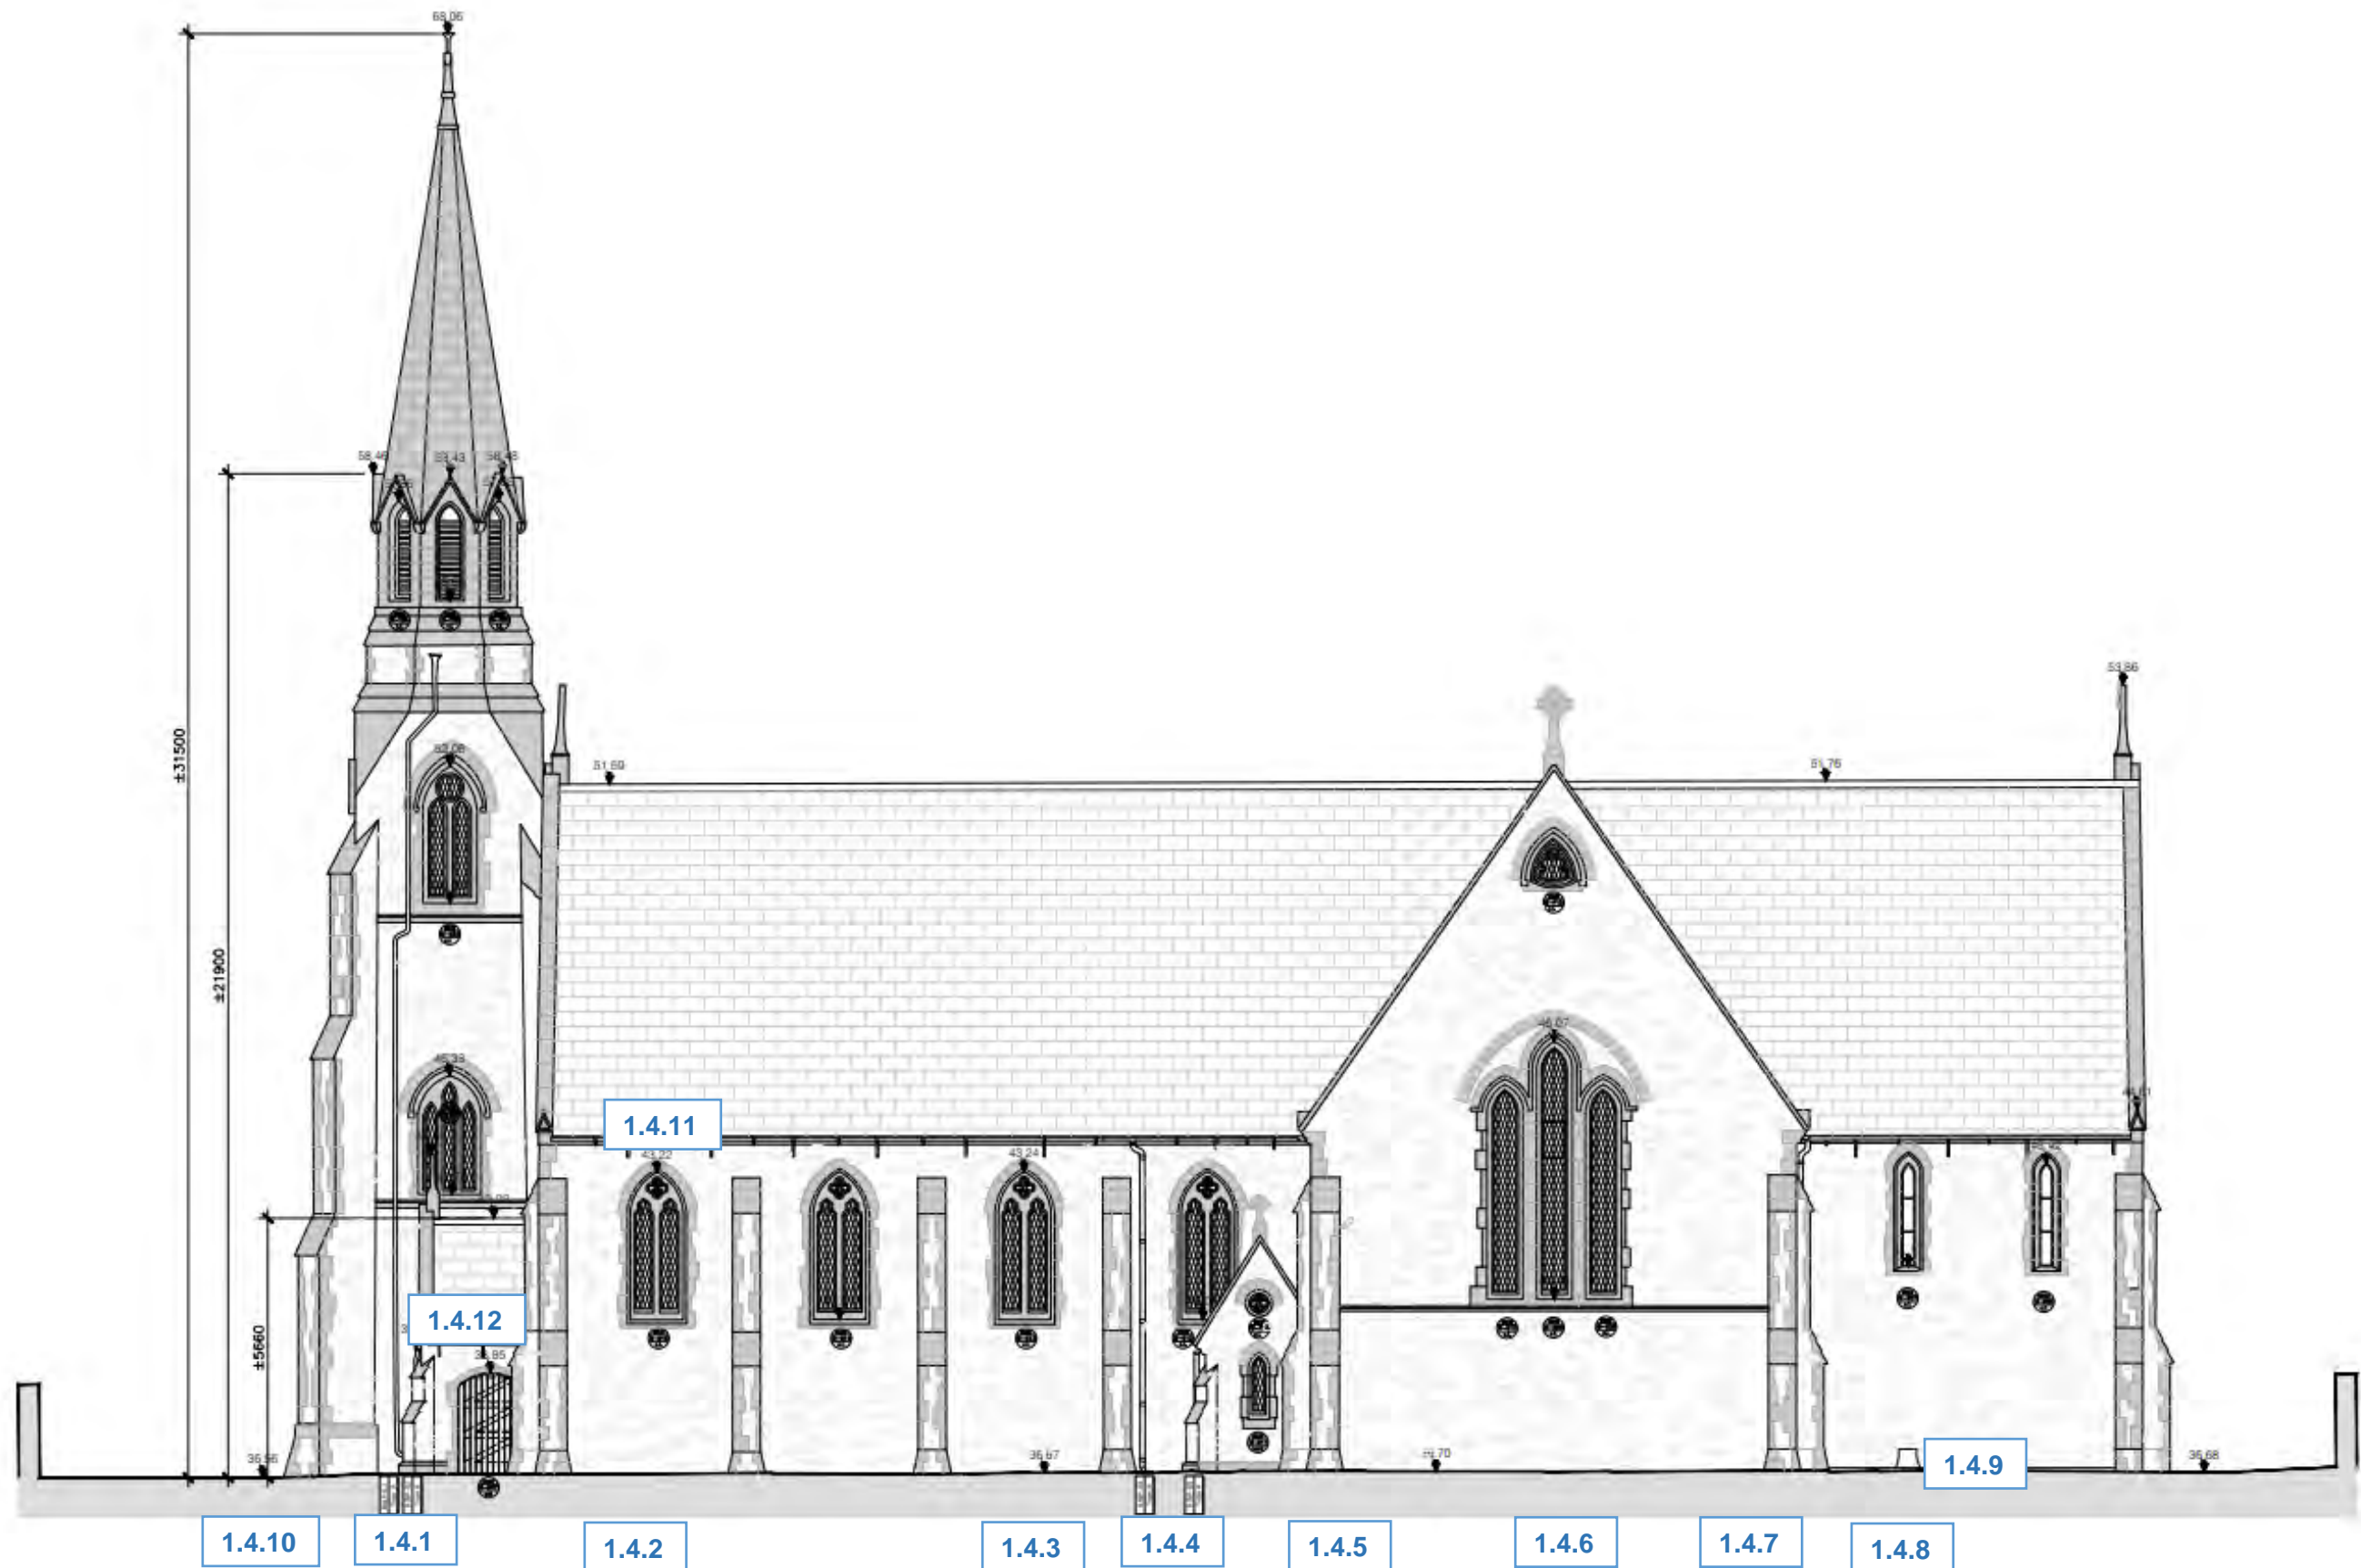
1.4 Existing East (Rear) Elevation

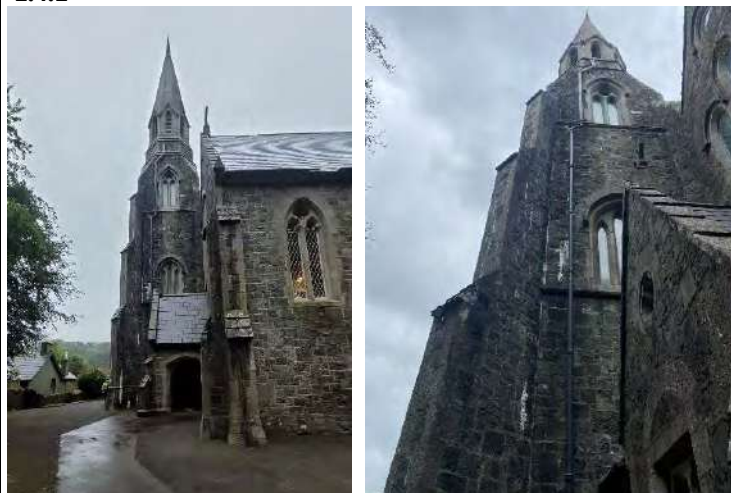
Bell tower view east. Entrance via south porch. Staining and lime leaching to stone. Extended rainwater pipe to top of tower. Secondary storm glass to bell tower windows.

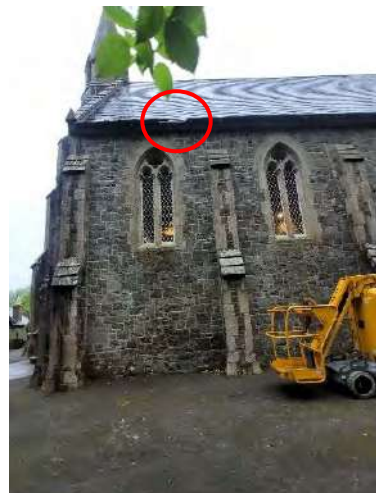
Windows W-G15 & W-G16. Broken section of gutter observed in July, temporary repair in place in August. Tarmac surface throughout.

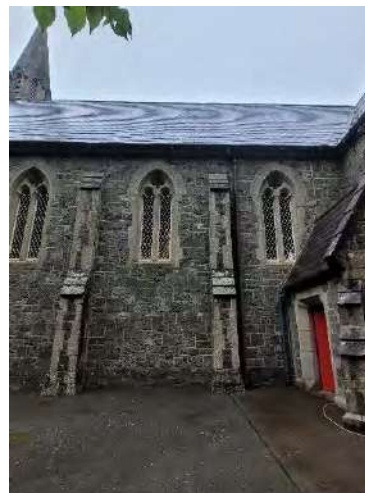
Windows W-G12 & W-G13. Entrance to north east porch. Tarmac surface throughout which has algae staining due to water ponding.

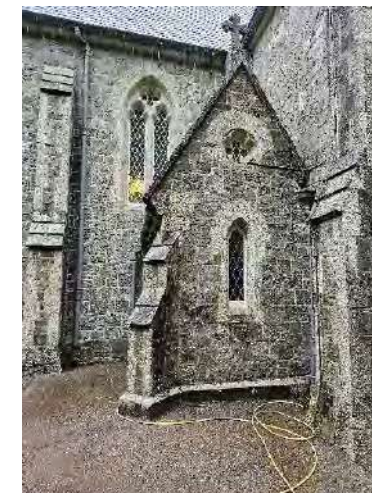
Window W-G11 north east porch. Tarmac surface throughout.

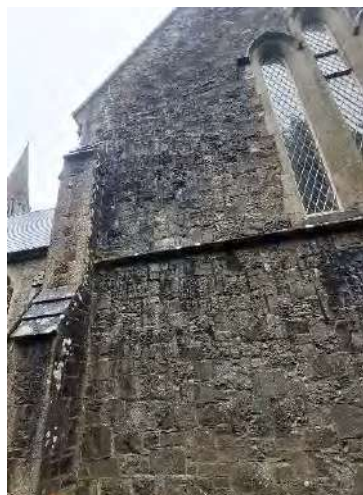
East transept; left hand side. Heavy staining and cementitious pointing to stone.

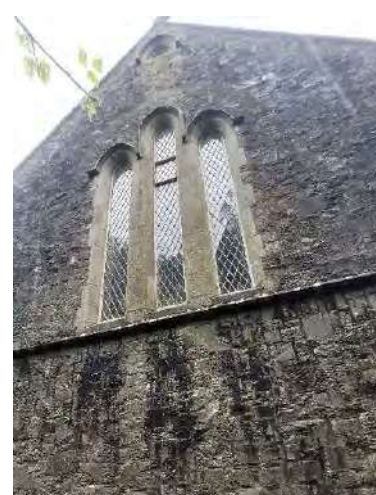
East transept; view centrally. Heavy staining and cementitious pointing to stone. Operable section of window not operational.

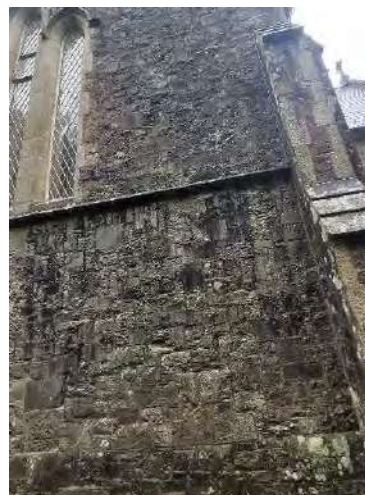
East transept; right hand side. Heavy staining and cementitious pointing to stone.

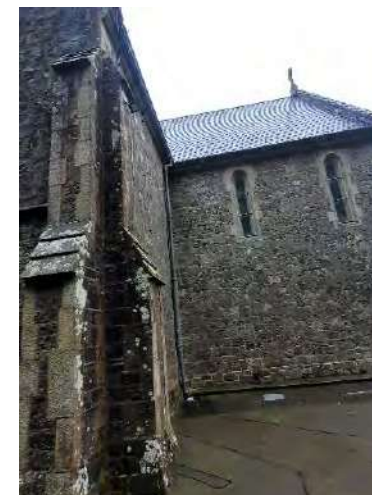
East wall of Alter. Windows W-G07 & W-G06 at high level. Heavy algae growth to ground surface due to water ponding.

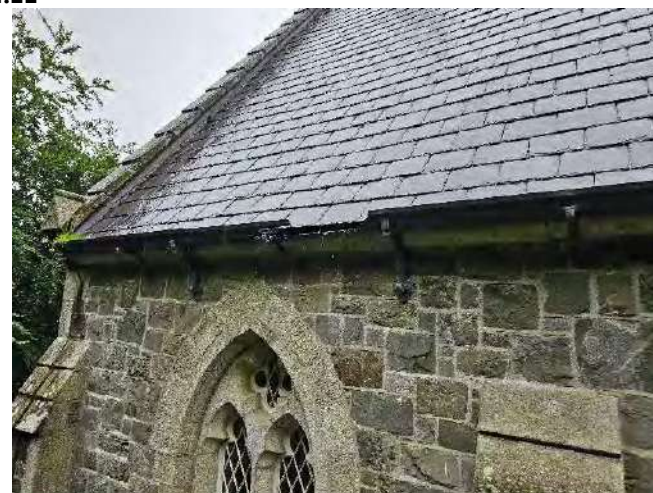
Broken section of cast iron gutter above window W-G15 seen in July and temporary repair in place in August. Broken due to falling ridge tile which damaged gutter.

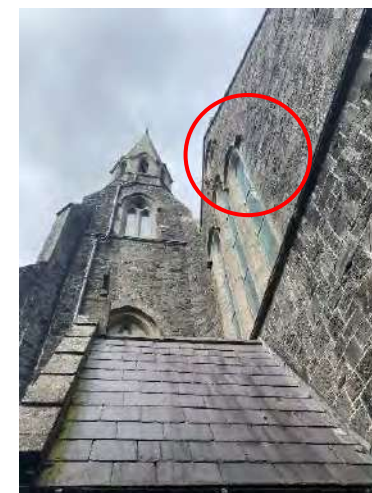
South elevation. Roof F, pitch F2. Note vegetation growth to window W-G27 and secondary storm glazing to exterior face. Lead flashing minimal to roof junction.

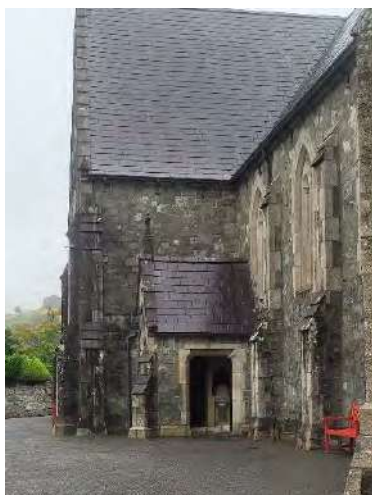
North west entrance porch presently main entrance; view south of west transept. Few slipped slates noted to high level roof.
