SS Mary & Patrick's Church, Avoca, Co Wicklow

For: Avoca Parish
Date: August 2023
Job Ref: 18-32
Issue Date: Sep 2023

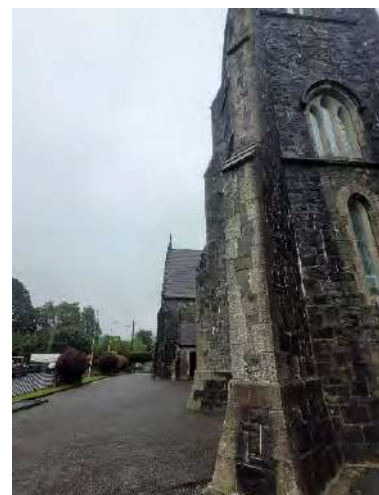
Bell tower; south elevation. Heavy staining and lime leaching to stone. Tarmac surface throughout.

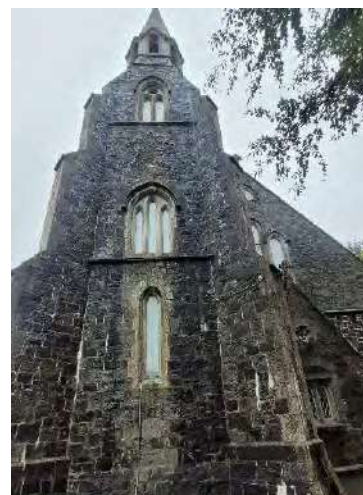
Bell tower; south elevation; central view. Secondary storm glazing to windows. Lime leaching to stone.

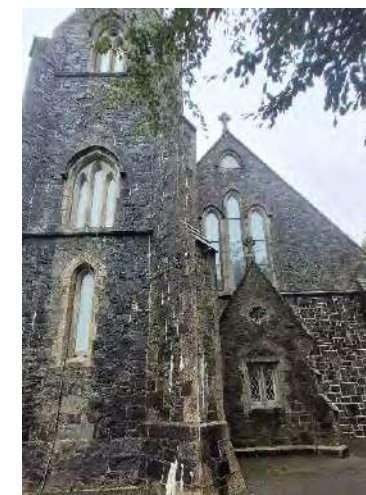
Bell tower & south elevation; Heavy staining and lime leaching to stone. Secondary storm glazing to

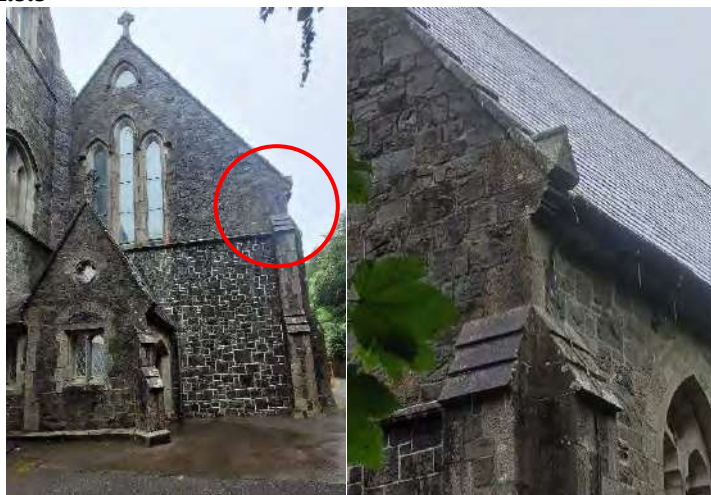
South elevation. Tarmac surface throughout in poor condition. Granite stone coping stone detail.

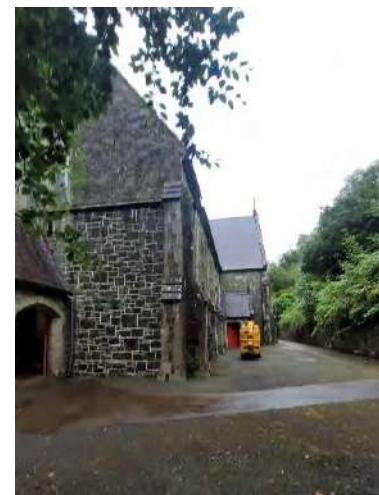
North east entrance porch; view south of east transept. Tarmac surface throughout with algae growth.

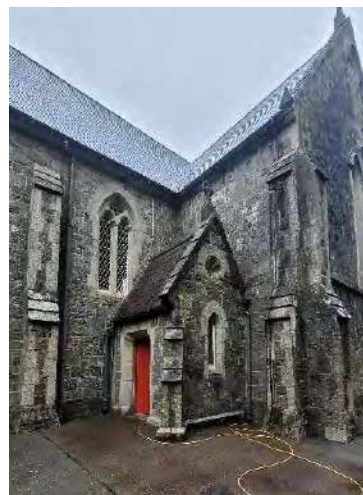
North east entrance porch. Heavy staining to stone.

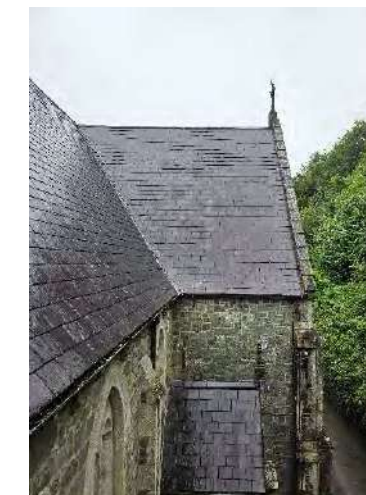
South pitch of East Transept Roof. Roof A, pitch A8 and Roof E, pitch E1 (to entrance lobby). Some localised slipped slates.

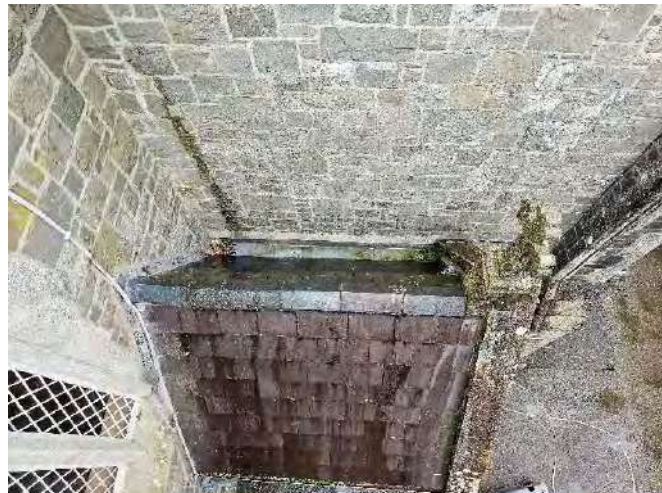
Valley gutter and roof E, pitch E2, to north east entrance porch in poor condition.

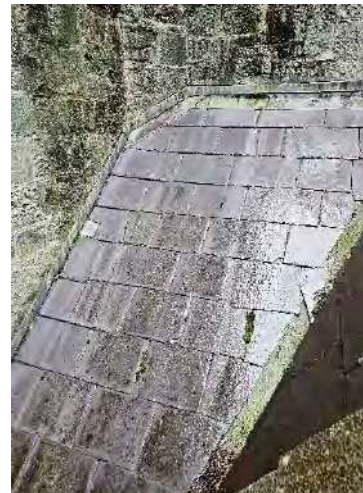
Roof G to the south porch in poor condition; broken and slipped slates, algae growth, minimal lead flashing against stone wall.

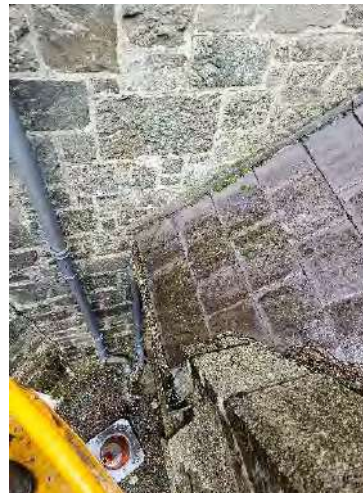
RWP-01 and RWP-02 to the bell tower and Roof G. Cast iron gutter blocked and causing staining to slated roof.

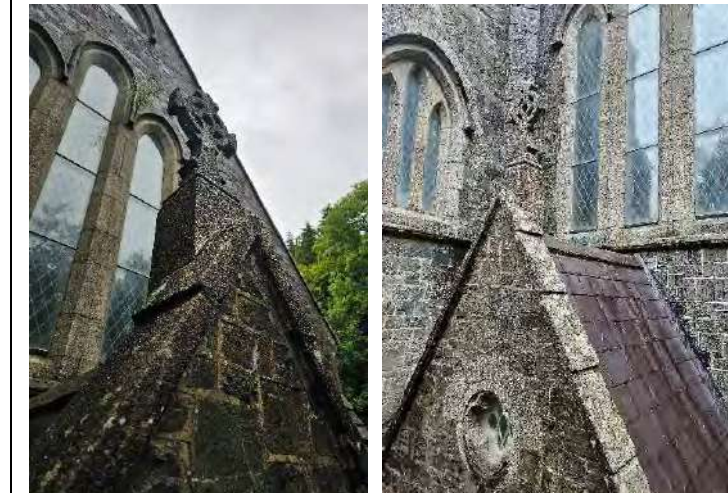
Granite coping stone and detail to Roof F, pitch F1 with minimum lead flashing detail. Secondary storm glass to windows.

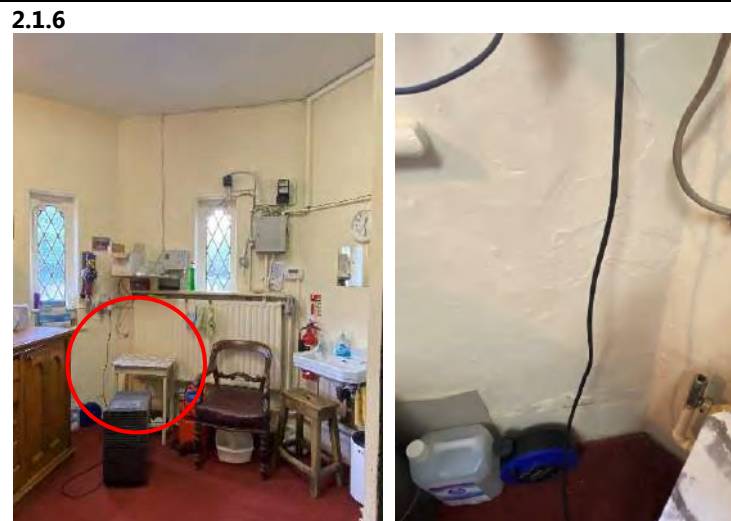
View towards north wall of the sacristy, below window WDW-G03 patches of previously repaired boasted plasterwork. Note ESB meter.

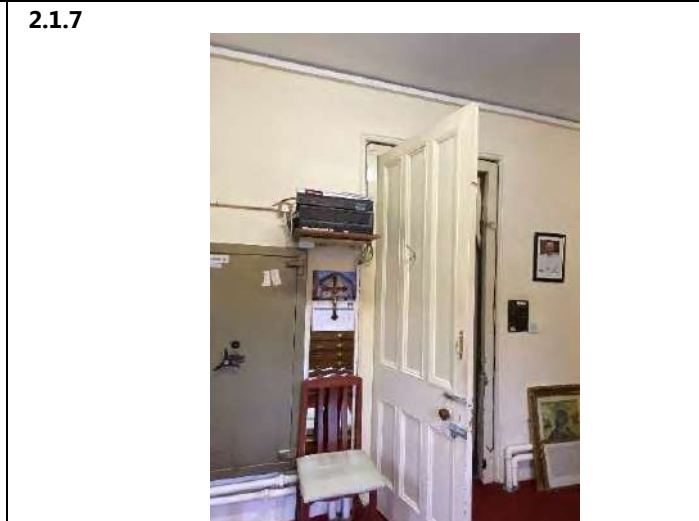
View east to door G-D03. 6no. panelled door with decorative moulding. Paintwork in poor condition.

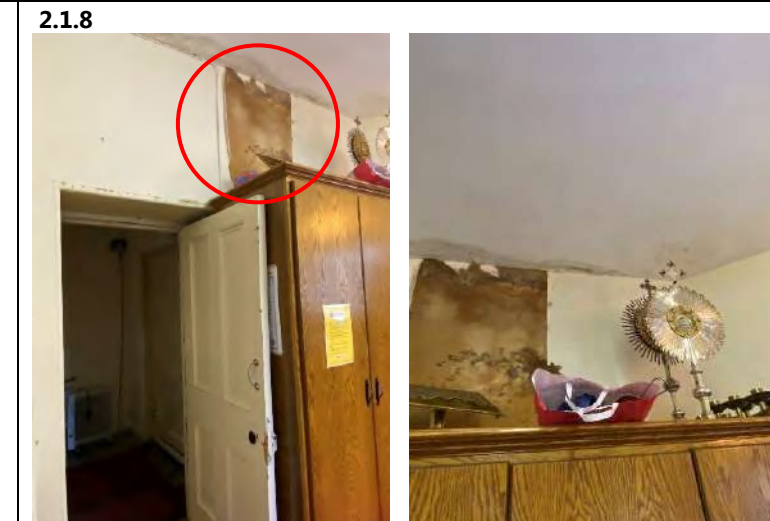
View south east towards door G-D02. Section of active dry rot visible at high level. Staining to wall and ceiling in this location.

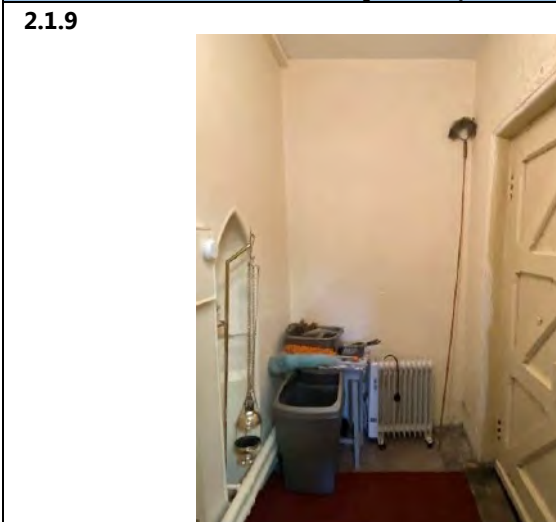
View south in entrance lobby to sacristy.

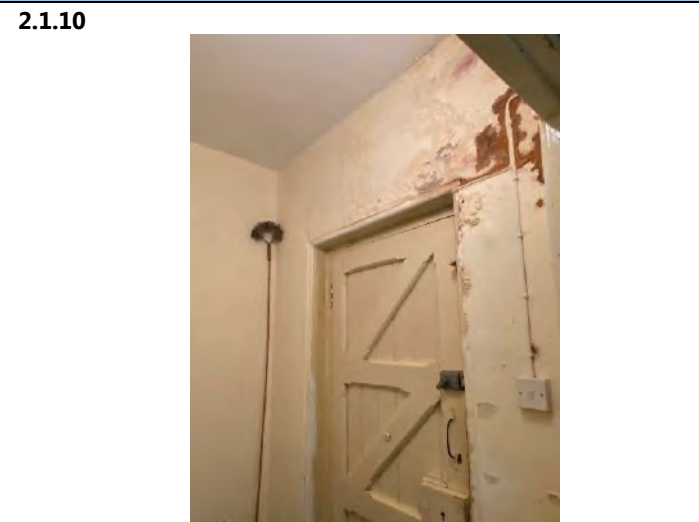
View west to external entrance door. Active dry-rot and damp to wall and ceiling. Plaster finish in very poor condition.

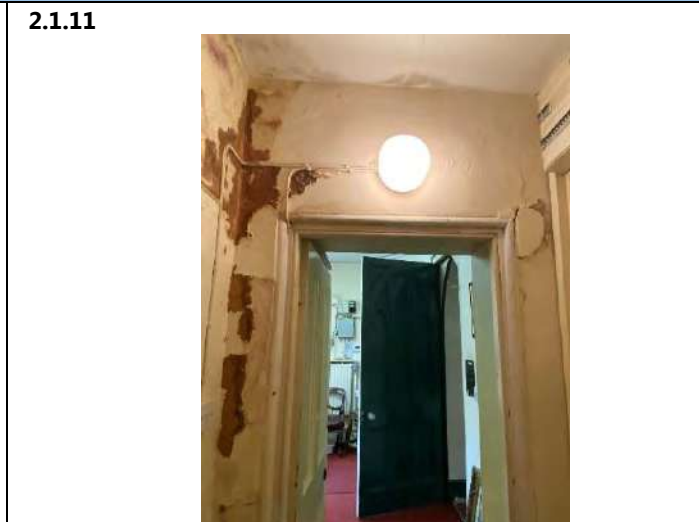
View north towards door G-D02 leading to sacristy. Active dry-rot and damp to wall and ceiling. Plaster finish in very poor condition.

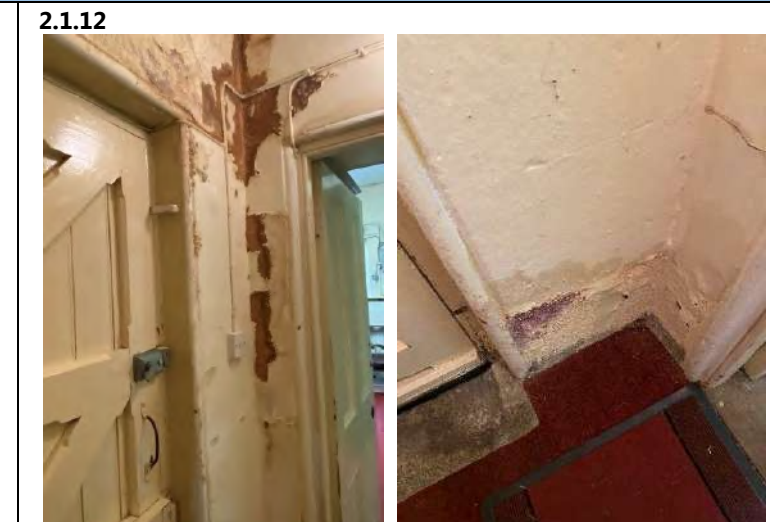
Section of active dry rot and damp to the left hand side full height. Corresponding with defects at roof and rising damp.

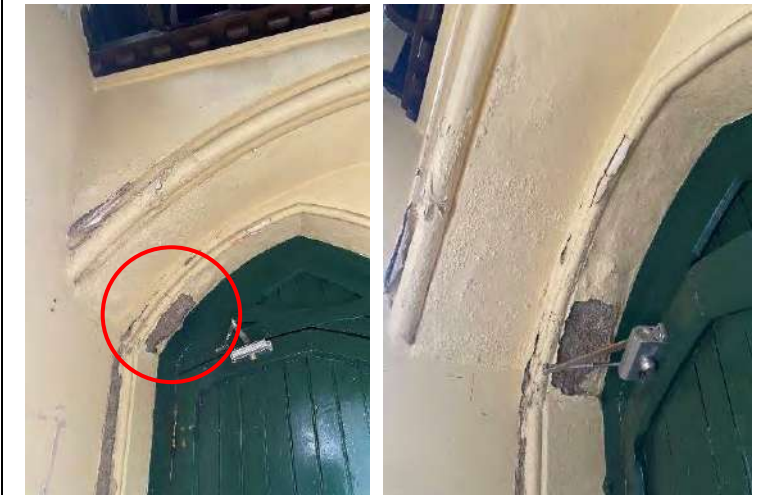
View north west to left hand side of door G-D12. Paint and plaster finishes deteriorated, corresponding with defect to gutter over.

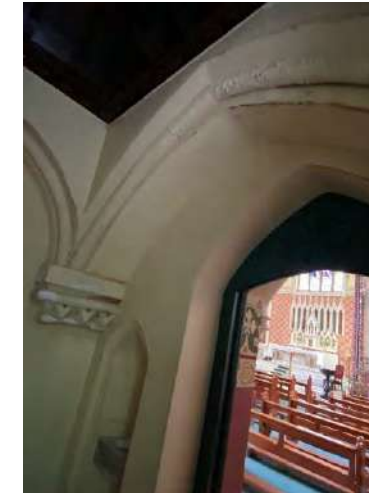
View north west including door D-G04. Paint and plaster finishes deteriorated, corrosion of metal beading apparent to head of door.

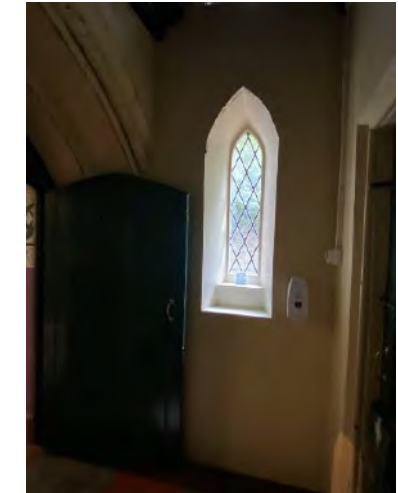
View east, windows W-G11. Possible dry lining to this external wall which is unvented. Corrosion of metal beading apparent to window.

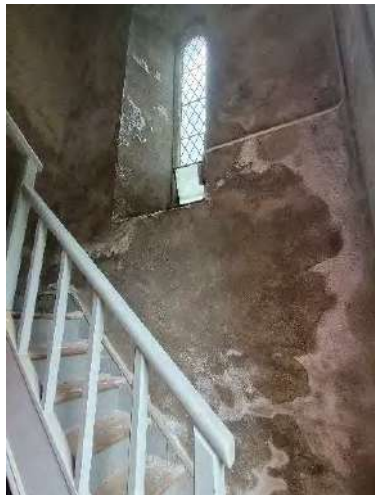
View south towards window W-G18. Significant staining (pink and brown) and efflorescence to wall consistent with algae presence.

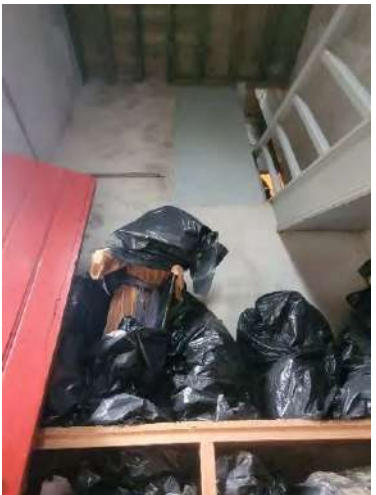
View north towards internal wall adjoining Nave. Storage shelving at ground floor level.

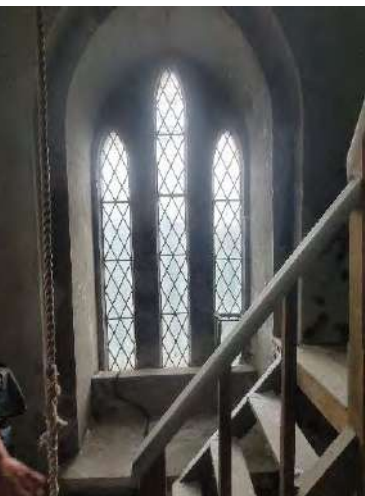
View west including window W-F04 at first floor level. Note bottom right section which appears openable, is not functional due to secondary storm glazing to exterior.

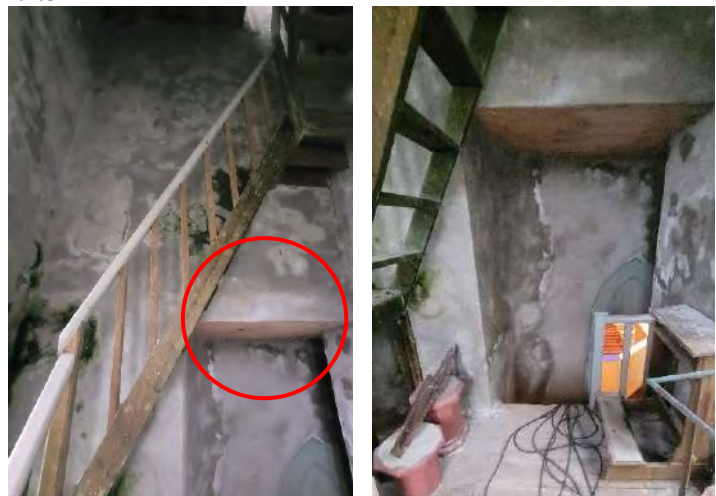
View of north wall, adjoining Nave, towards internal door F-D01 to choir balcony. Significant staining (vibrant green) to walls. Gypsum plaster finish to head of ope to the balcony door.

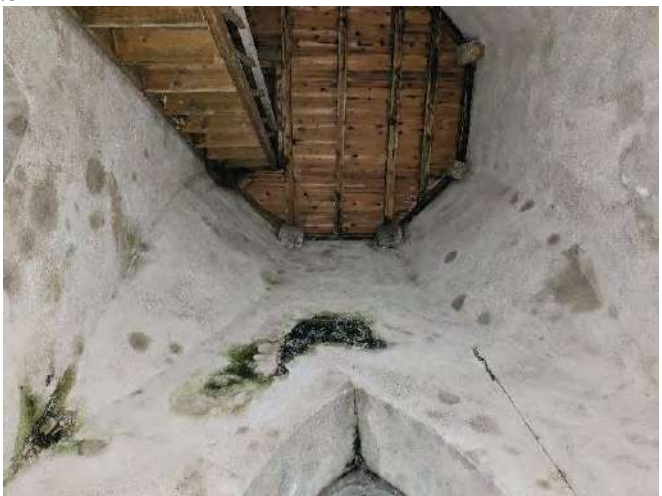
View to ceiling. No safe access to upper levels. Significant staining extends to full height of walls. Timber stair in this location rotten and decayed by wood-destroying insect.

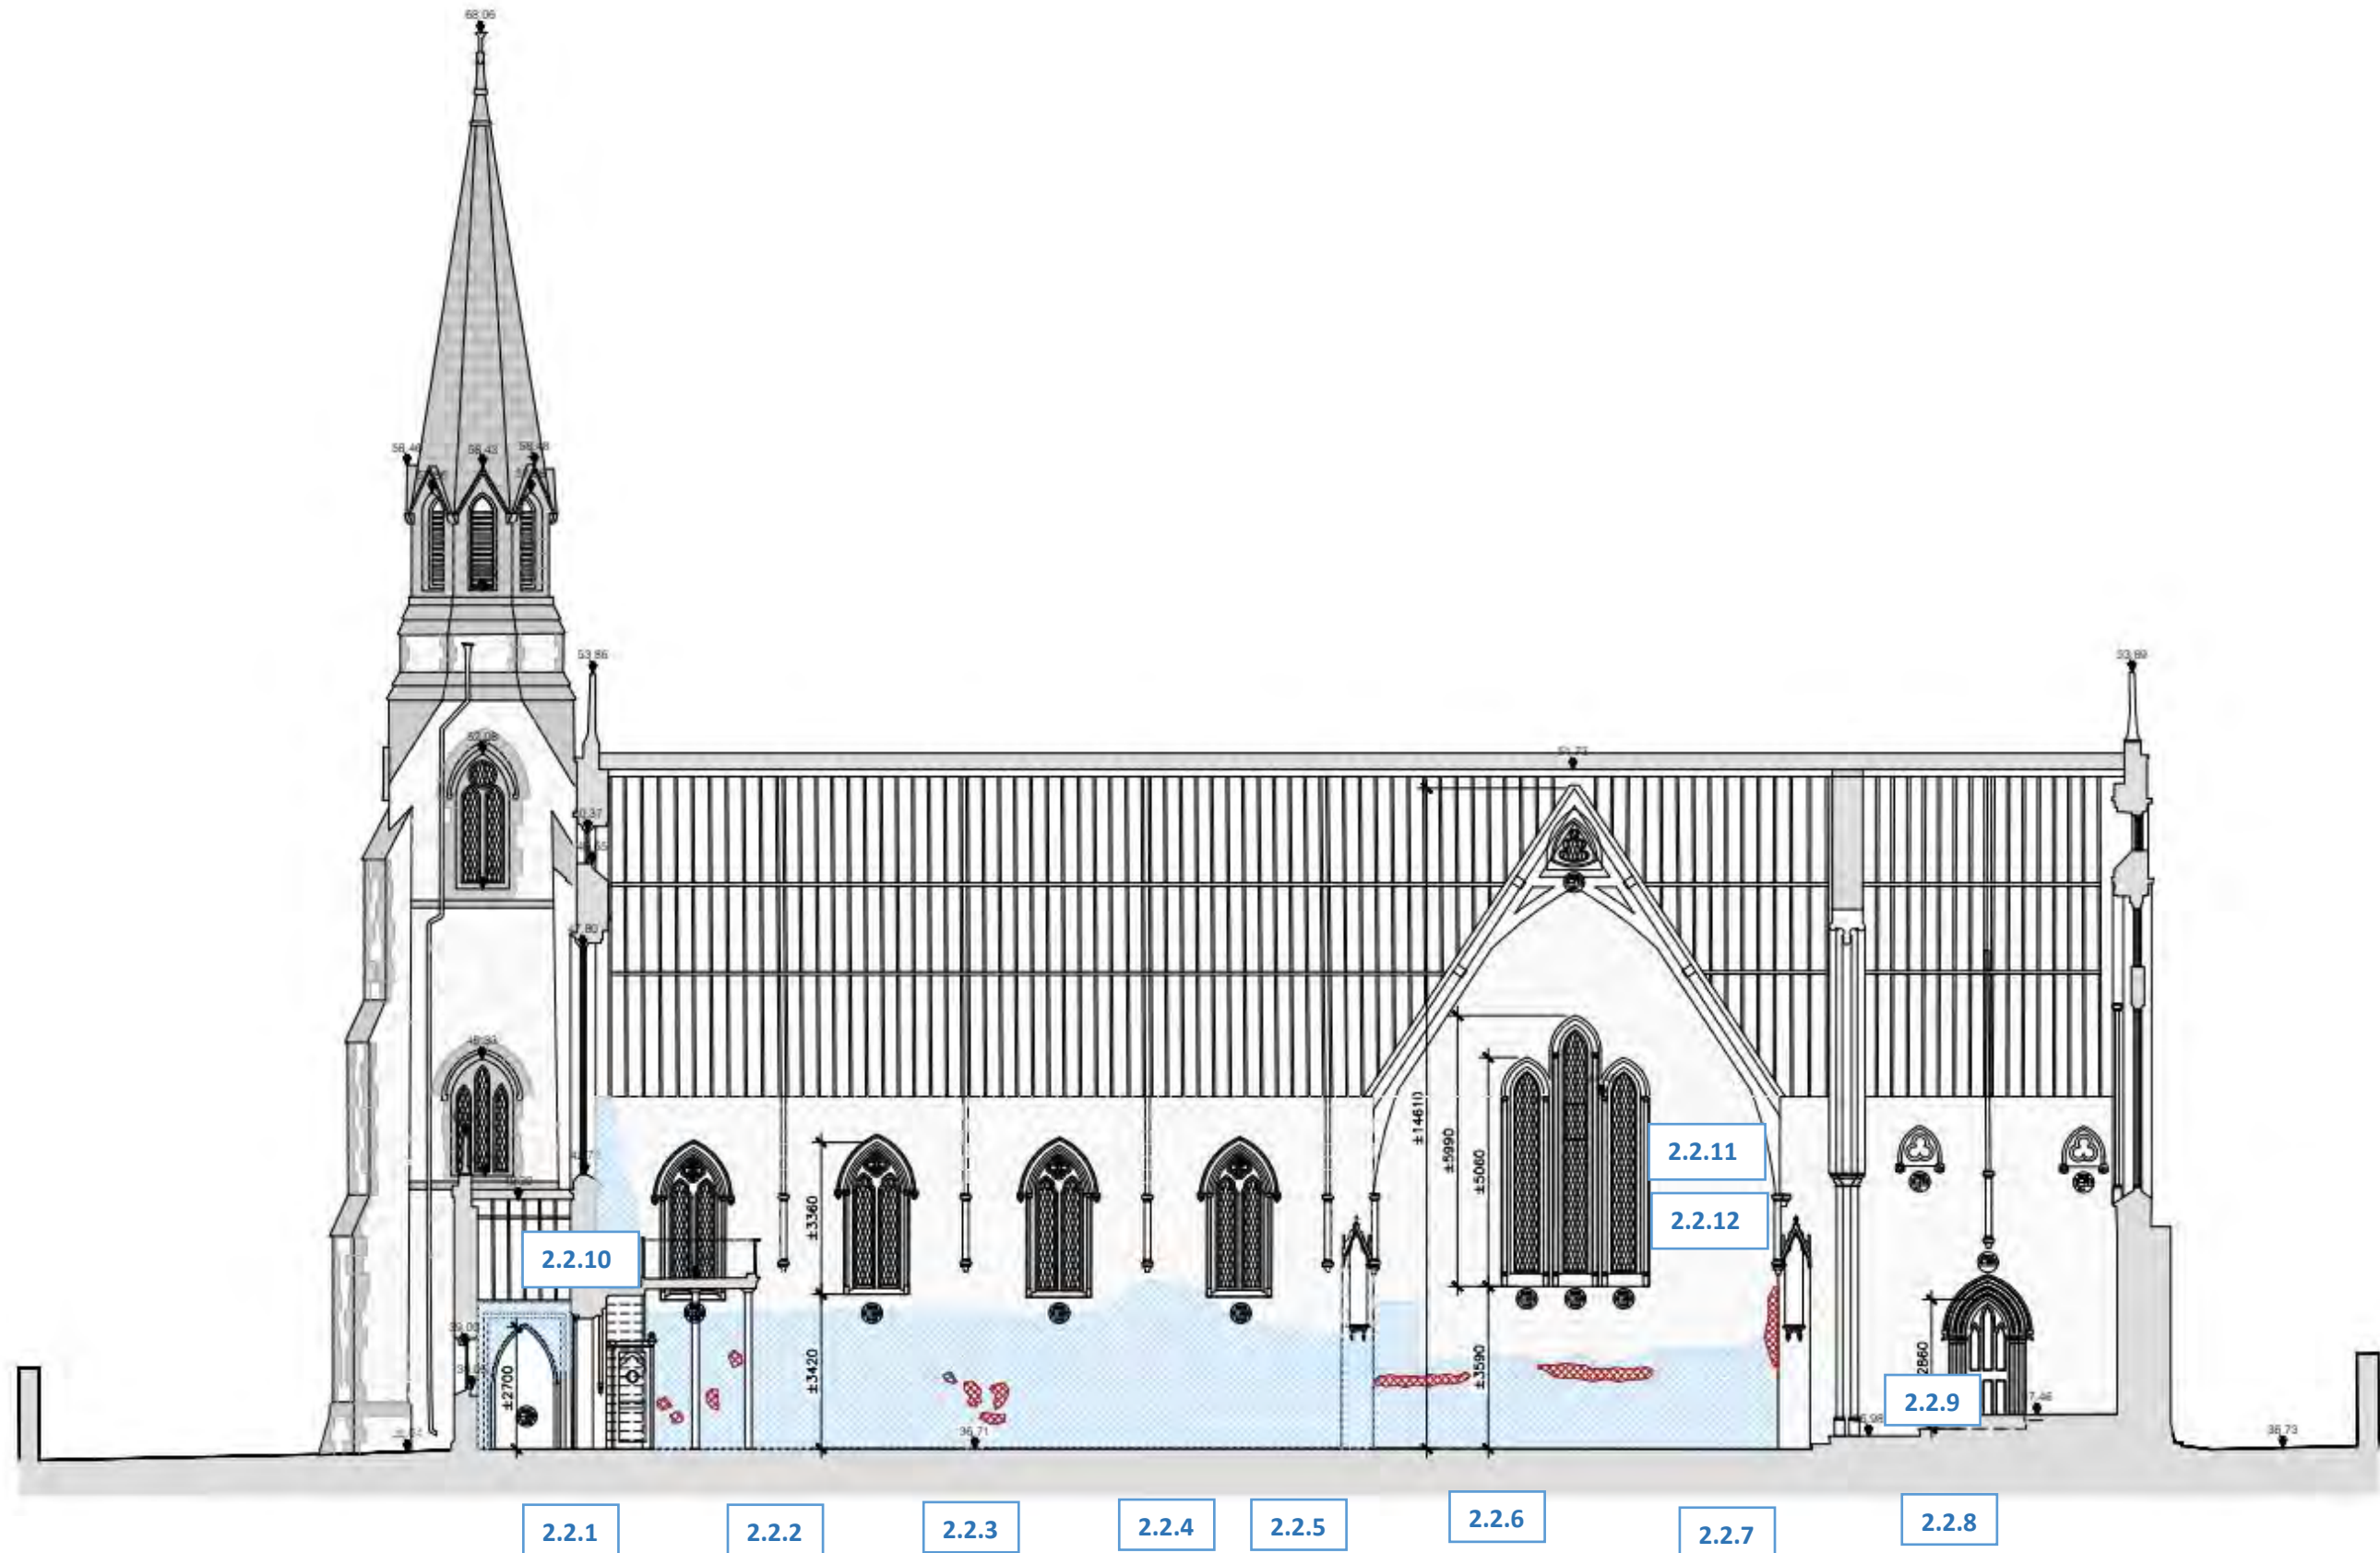
2.2 Existing Section A-A (View West)

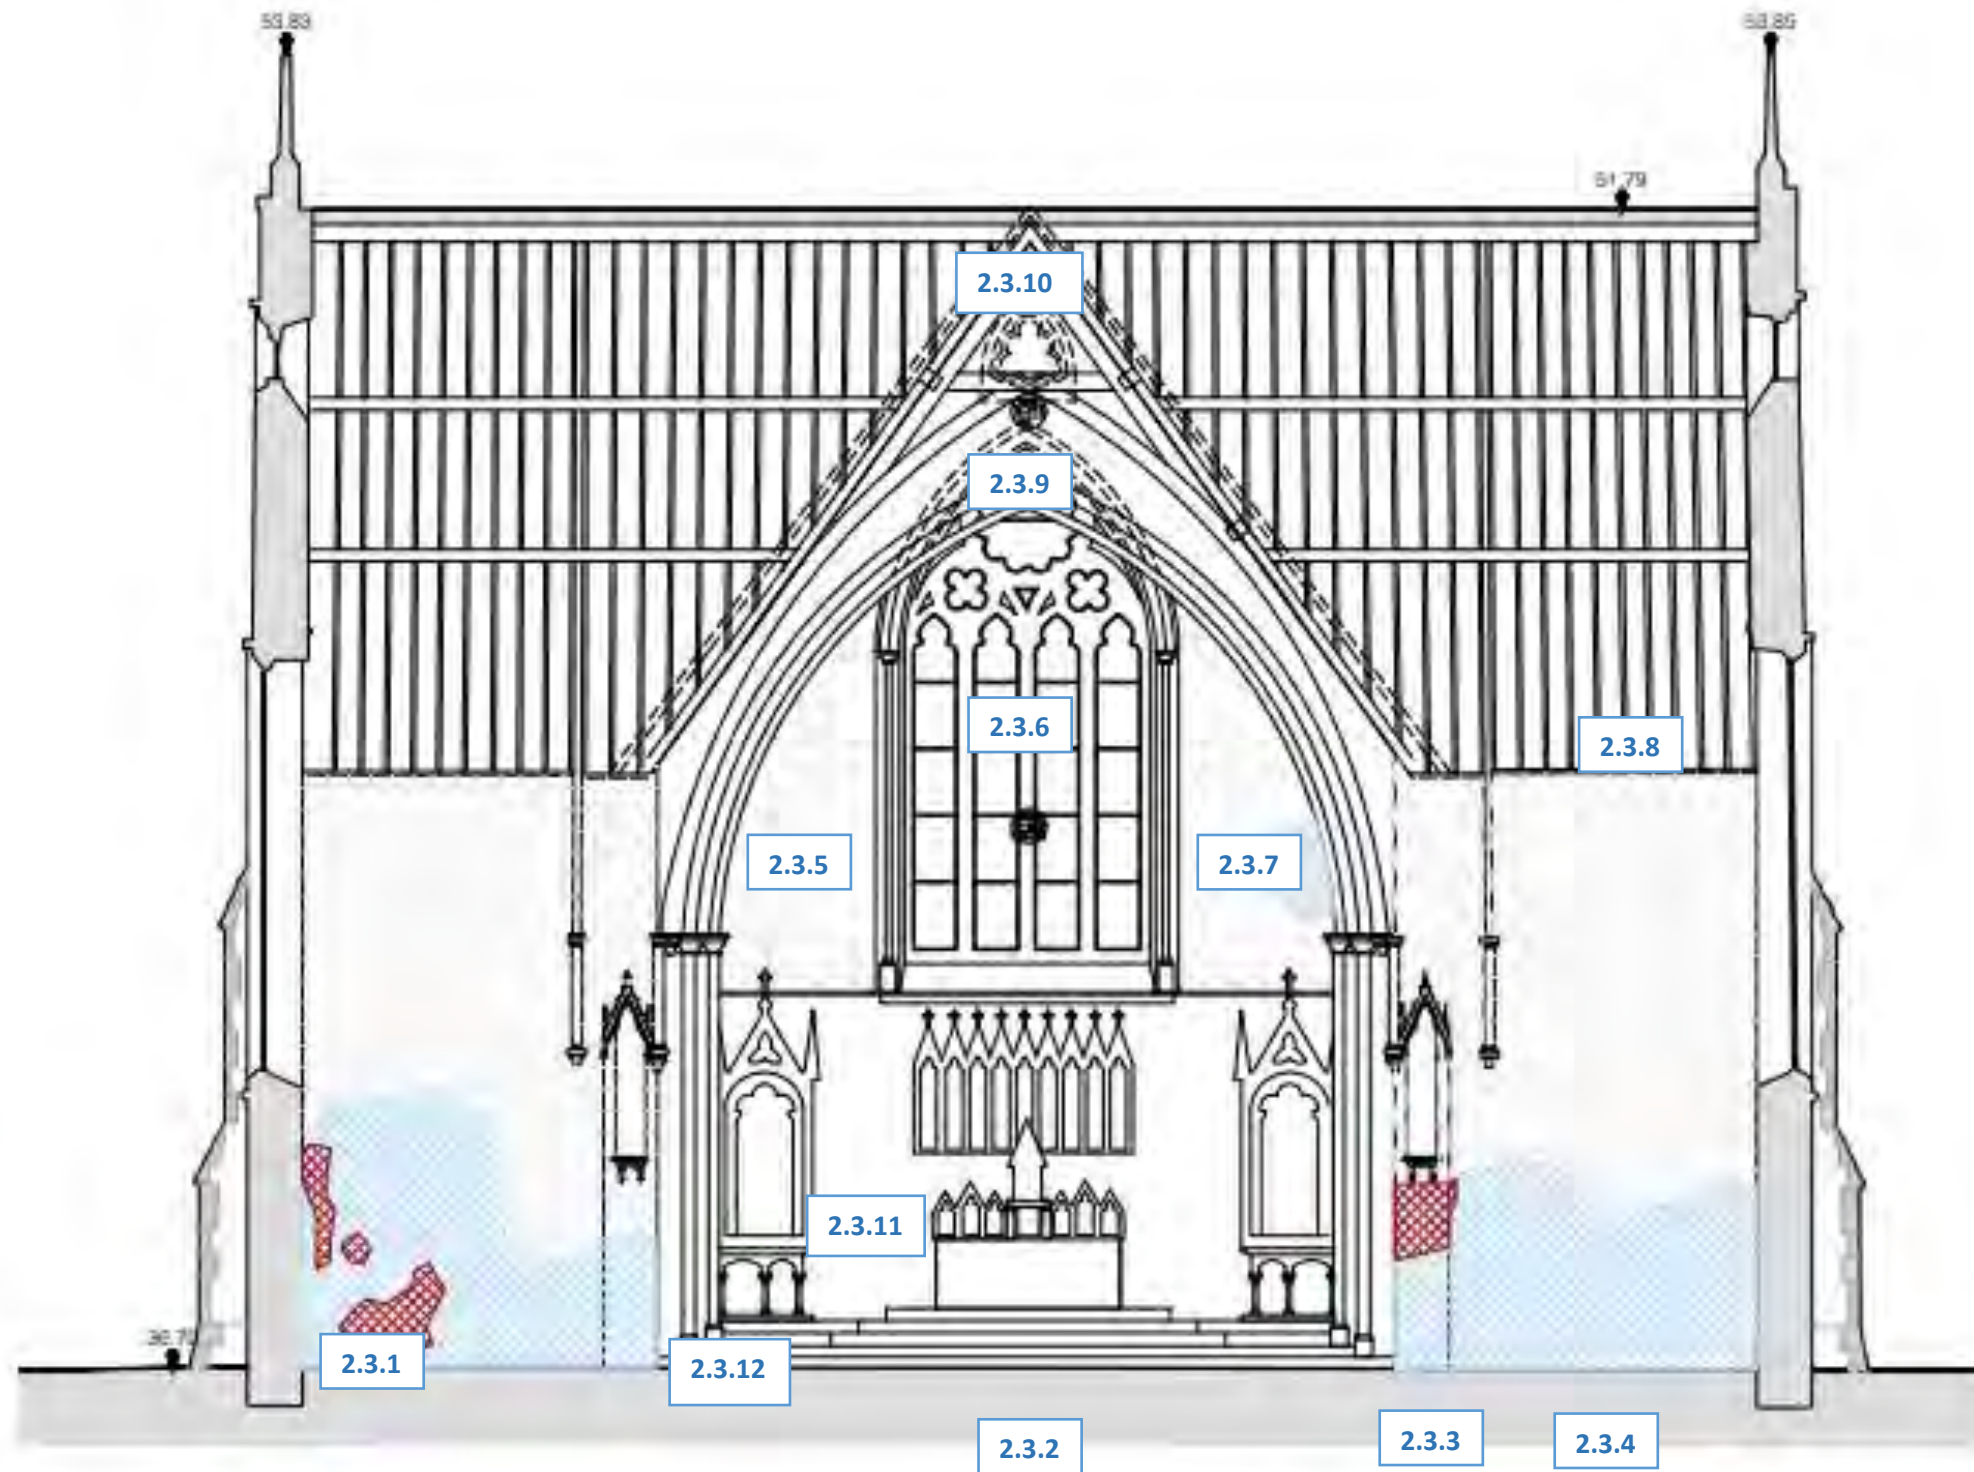
2.3 Existing Section C-C (View North towards the Sanctuary)

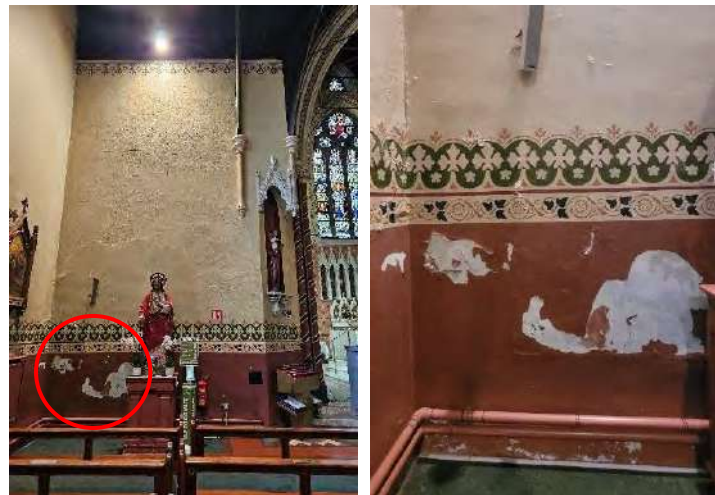
North wall view of the west transept in poor condition. Missing paintwork and boasted plaster. Areas has been partially replastered.

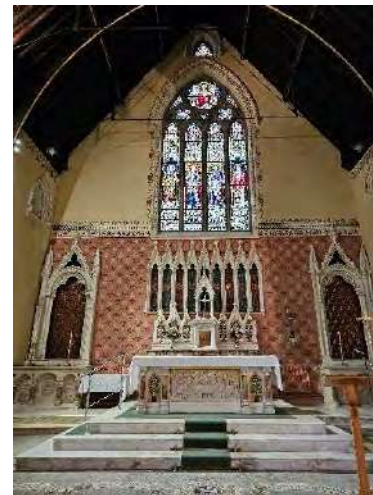
View north of the 3no. steps to the alter and stained-glass window W-G05. Lined-and-ruled plaster finish at high level.

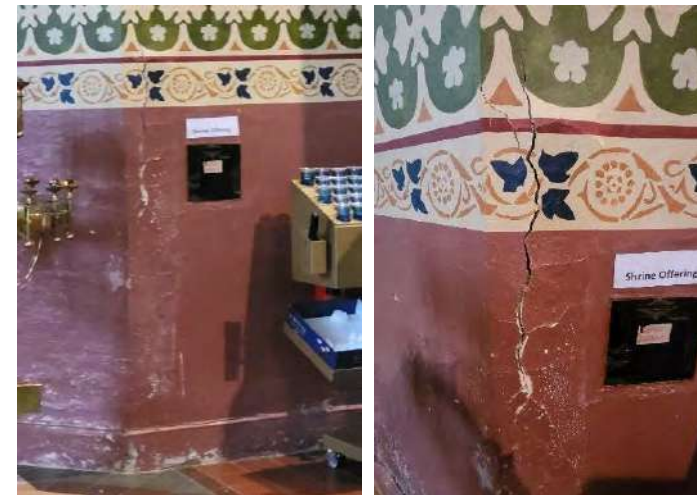
Corner junction between the alter area and the north wall of the east transept in poor condition. Cracking and boast plasterwork.

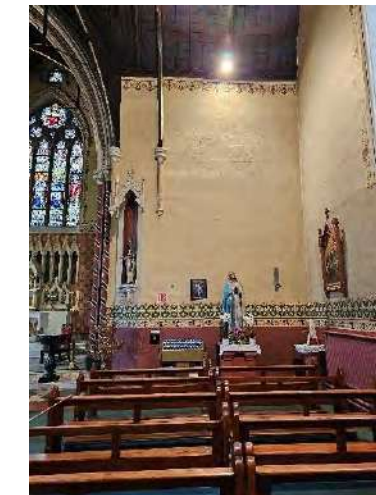
North wall view of the east transept in poor condition. Area appears to have been partially replastered.

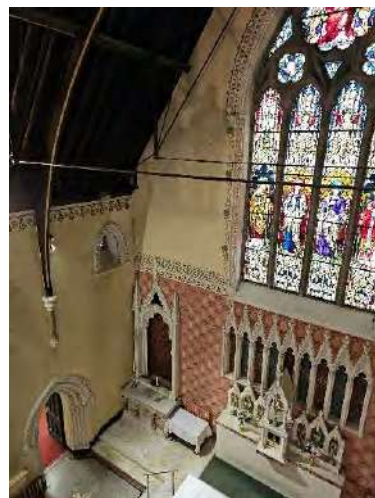
High level view of the alter lhs. Condition of stained glass window not assessed.

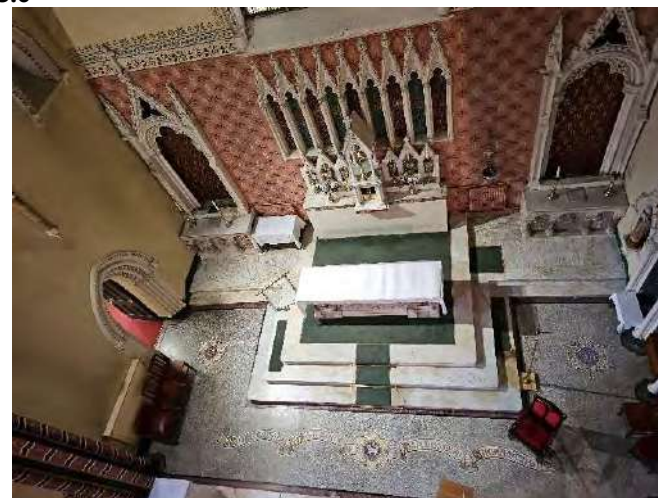
High level view of the alter.

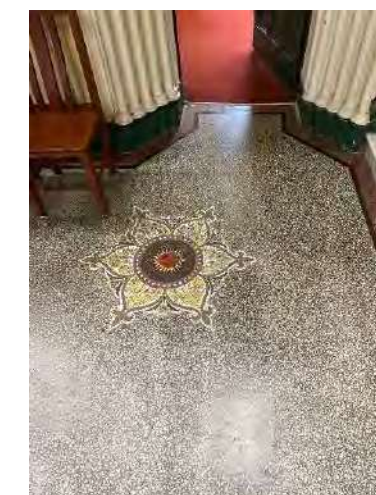
Decorative terrazo and mosaic flooring to alter including door G-D03, in good condition.

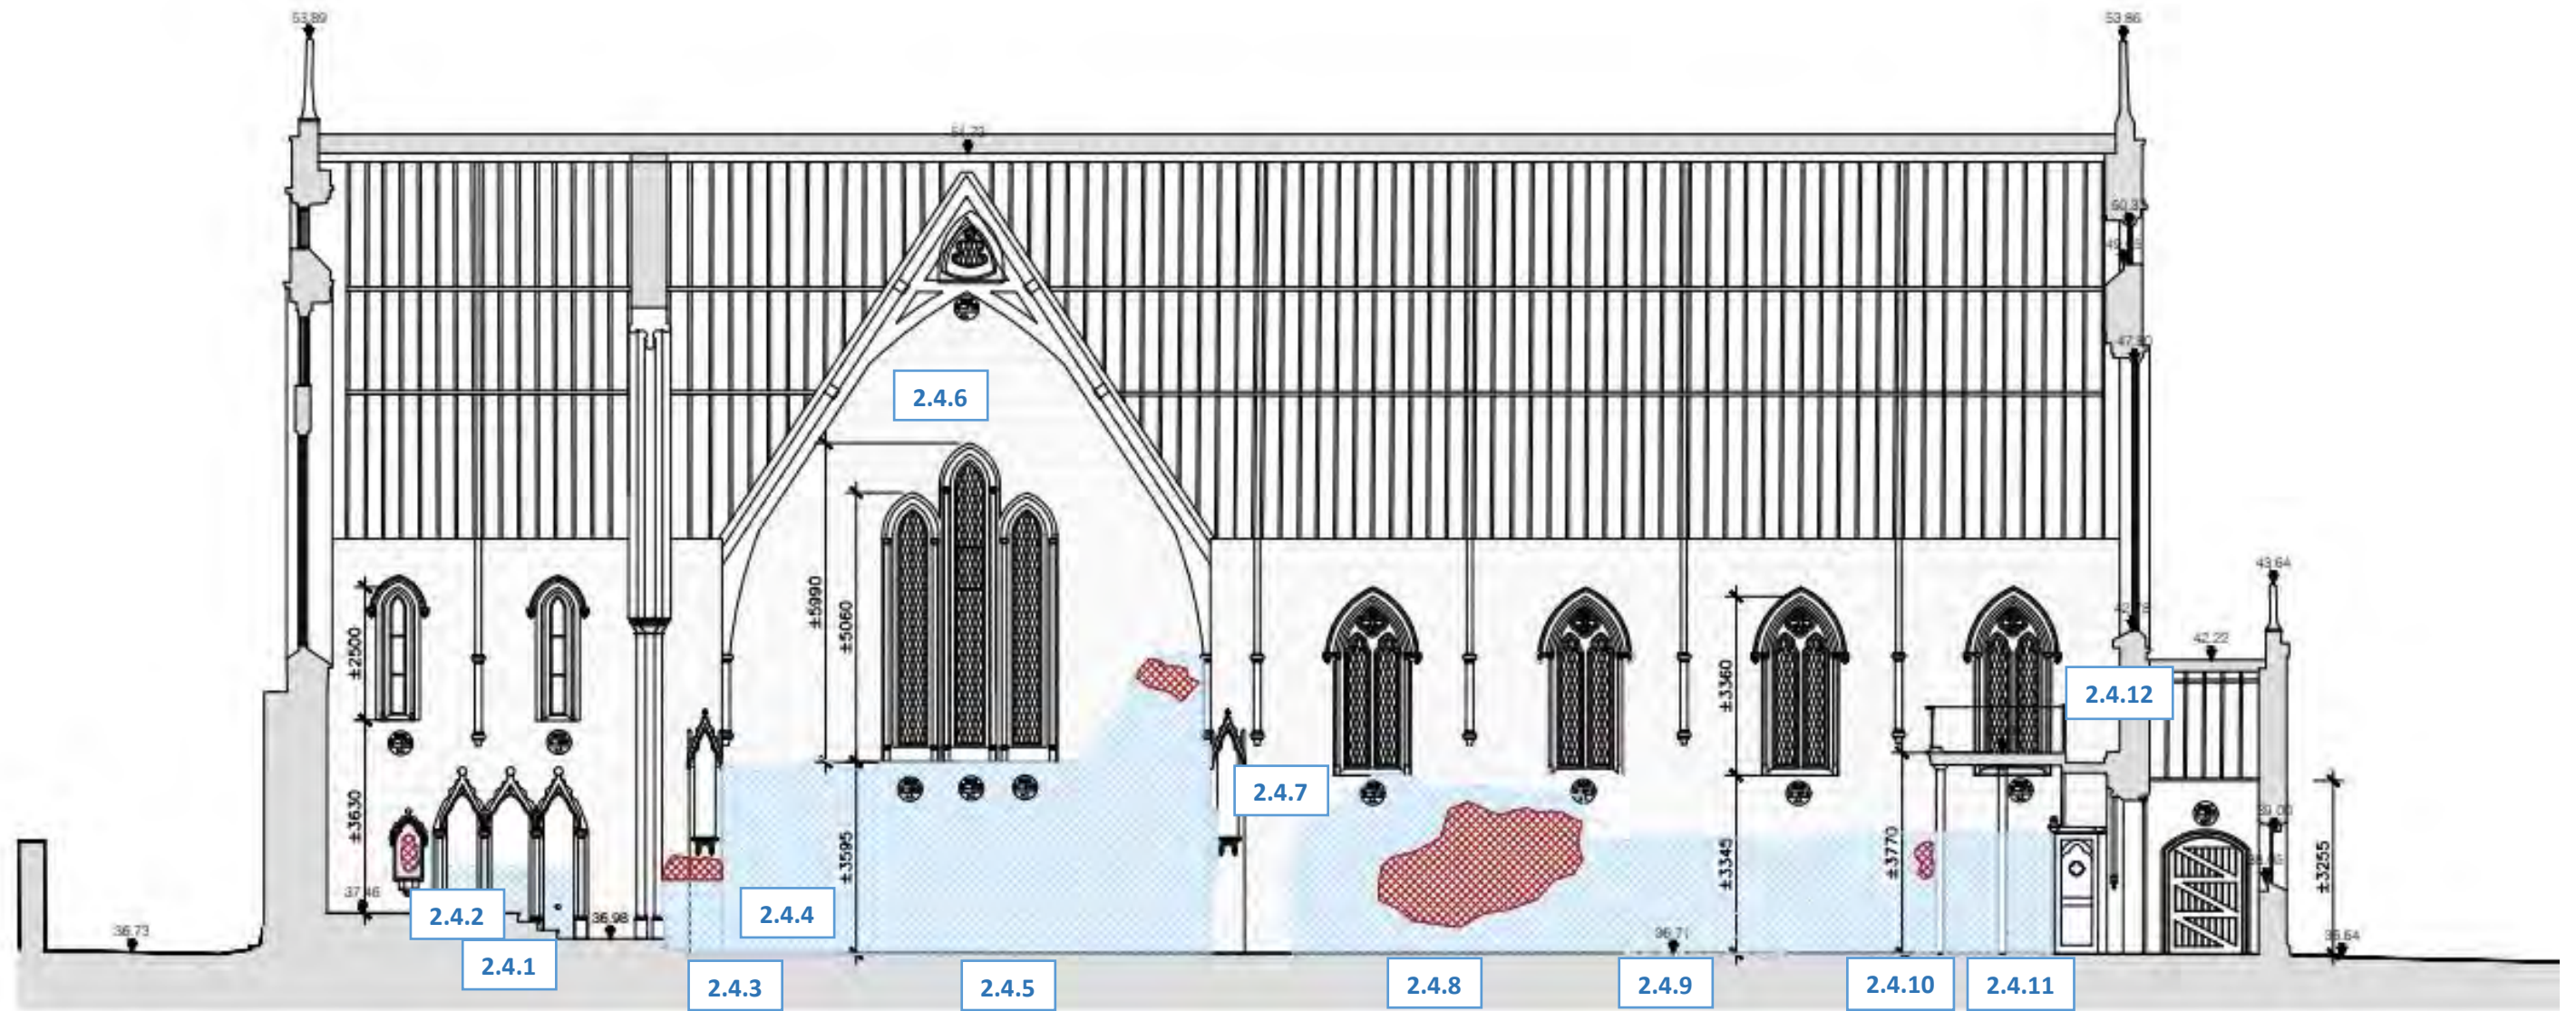
2.4 Existing Section B-B (View East)

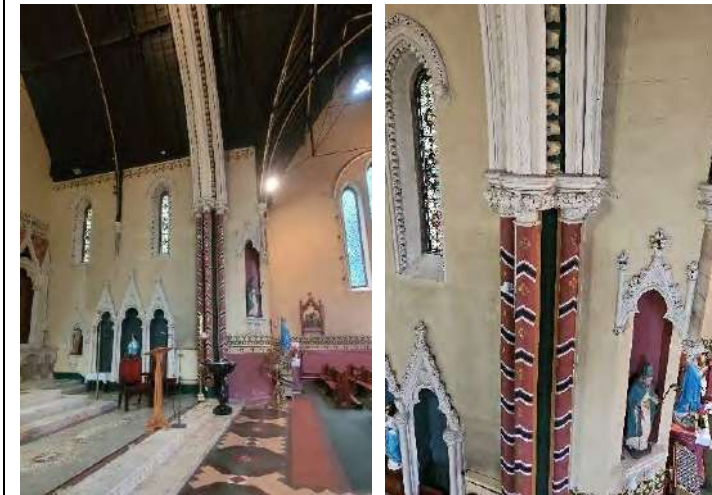
View of painted decorative plasterwork to ribbed arch above the altar in good condition.

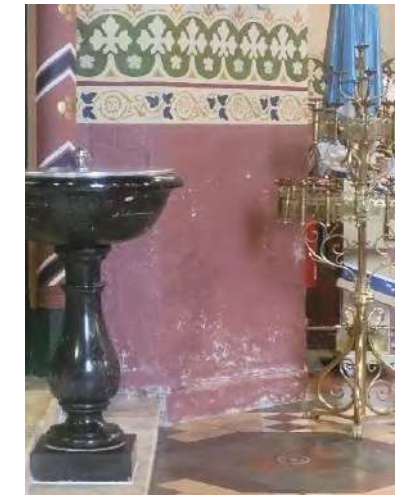
View of junction between the altar and the north wall of the east transept. Note modern replacement baptismal font and loss of detail to the plasterwork at low level due to repairs and rising damp.

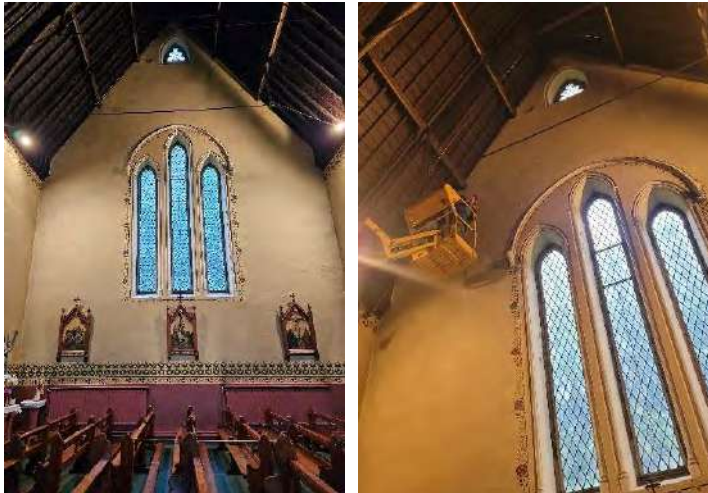
View of east transept. Random ashlar pattern to plasterwork at high level and flat finish to low level. Opening section to central window not operational.

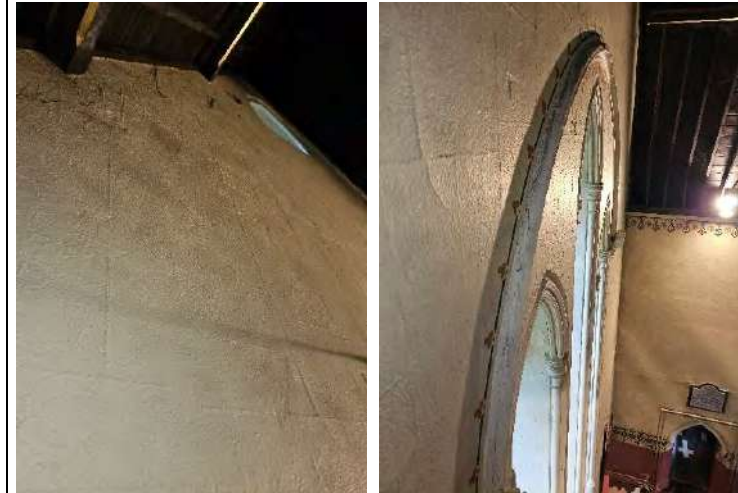
High level view above central window W-G08-10. Note plasterwork and paint finish in fair condition.

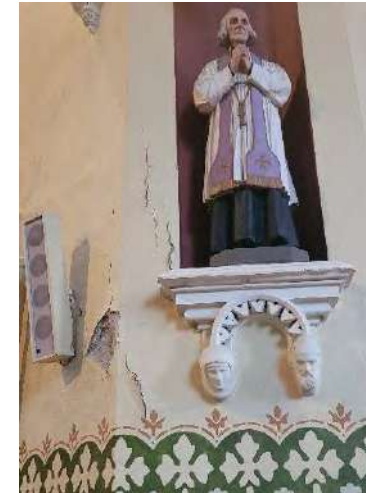
Decorative plasterwork detail to statue niche between the nave and east transept. Plasterwork boast and paint finish peeling.

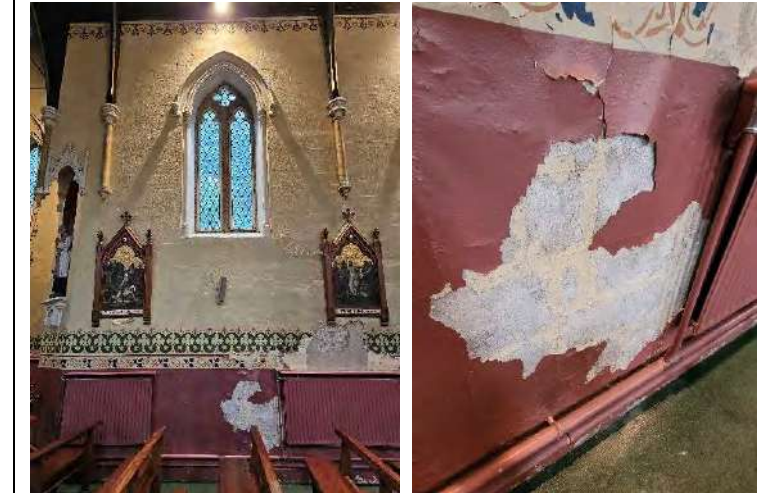
Window W-G12, fixed window. Large area of flaked paintwork and boasted plaster below cill level, which previous repairs have been undertaken.

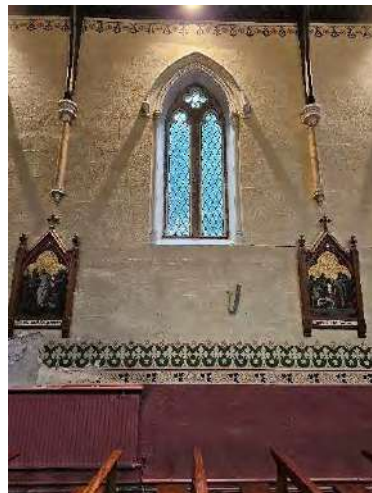
Window W-G13, fixed window. Loss of stencilled paintwork detail and boasted plaster below cill level. Plaster repairs apparent at low level.

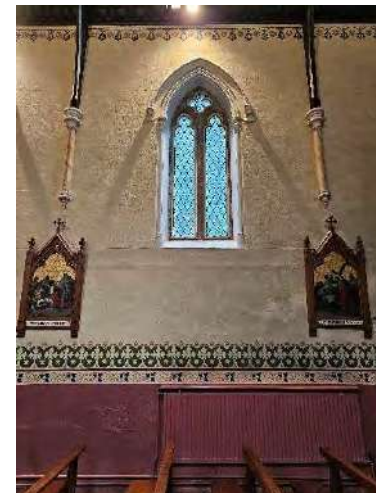
Window W-G14, fixed window. Radiator coming away from wall due to boast plaster. Plaster repairs apparent at low level.

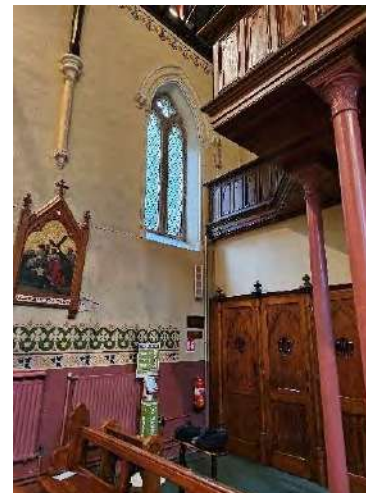
Window W-G15, fixed window. Boasted plaster below cill level. Plaster repairs apparent at low level.

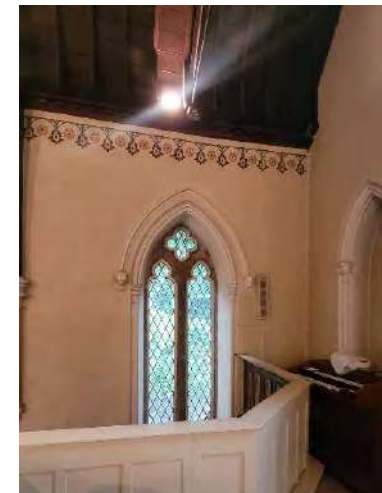
View from the choir balcony of windows W-G15, fixed window. Decorative paintwork stencilling at high level of wall.
