SS Mary & Patrick's Church, Avoca, Co Wicklow

For: Avoca Parish
Date: August 2023
Job Ref: 18-32
Issue Date: Sep 2023

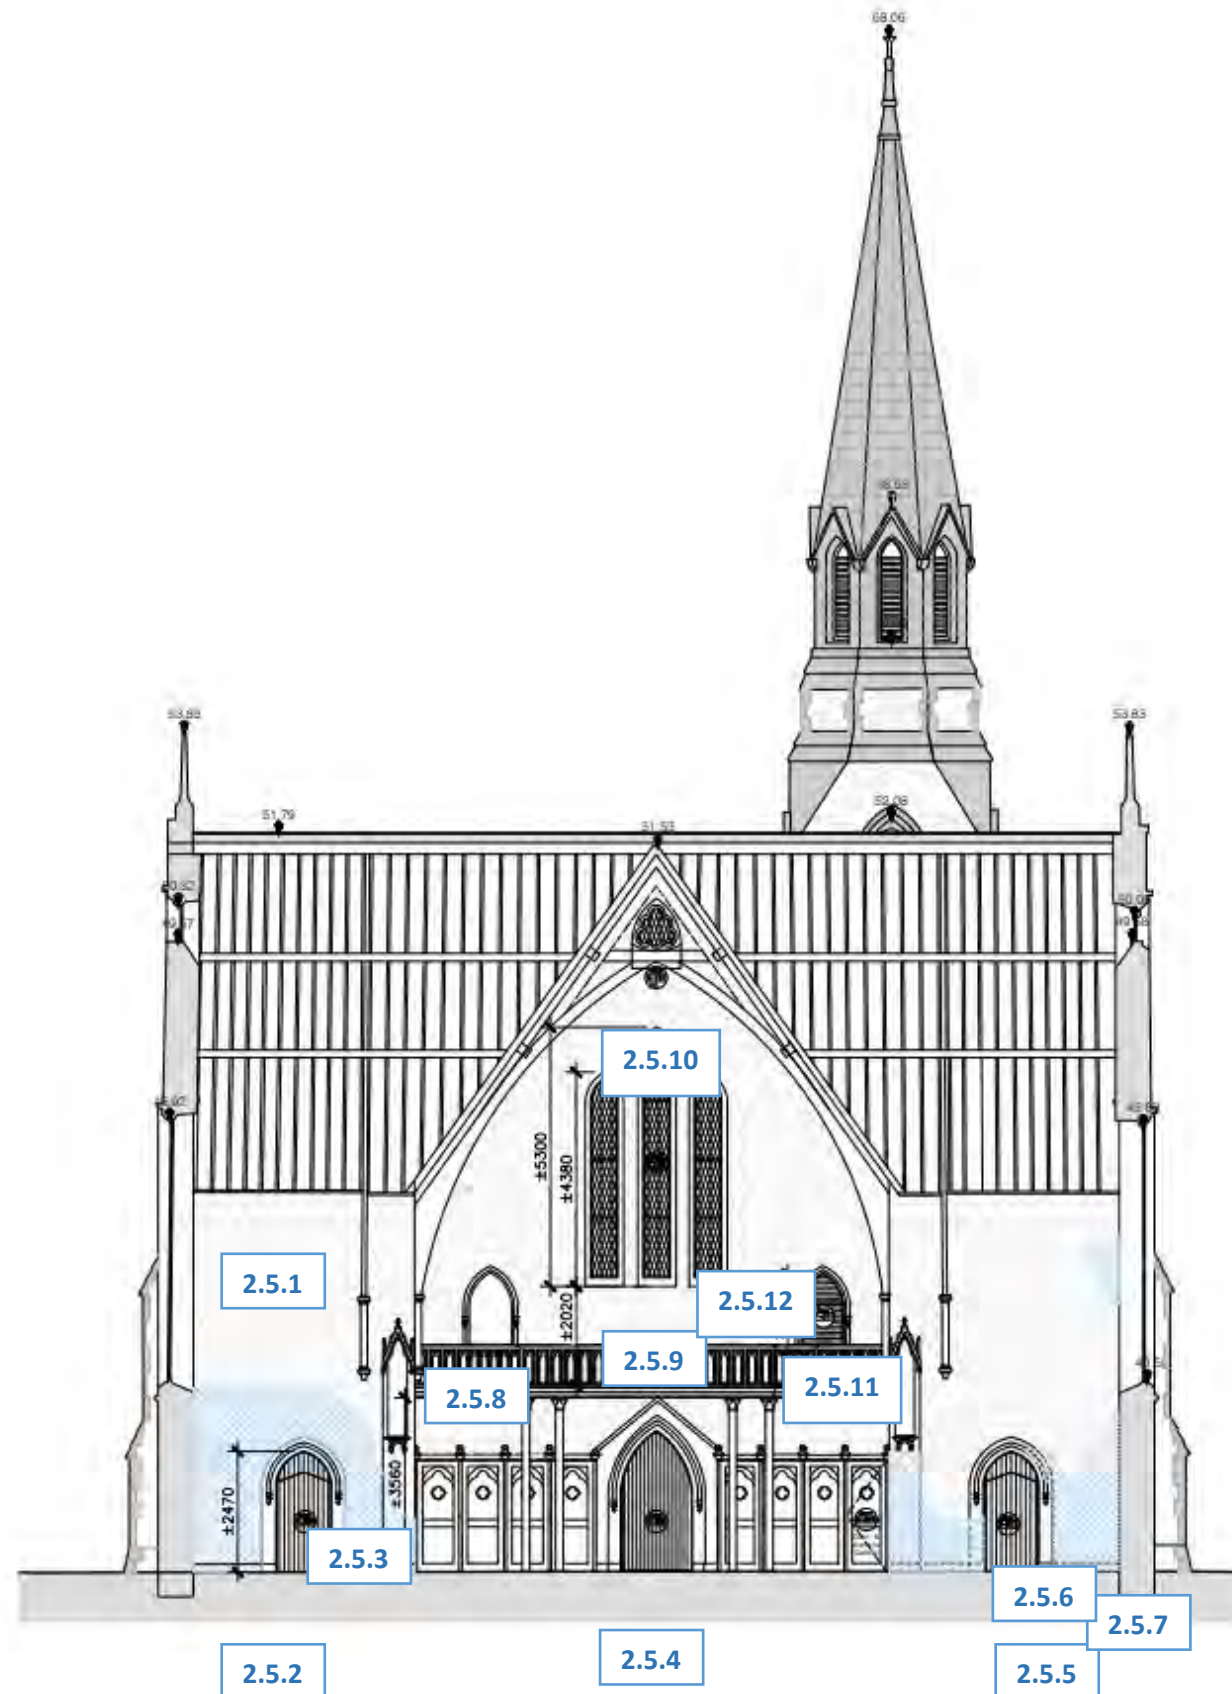
2.5 Existing Section D-D (View South)

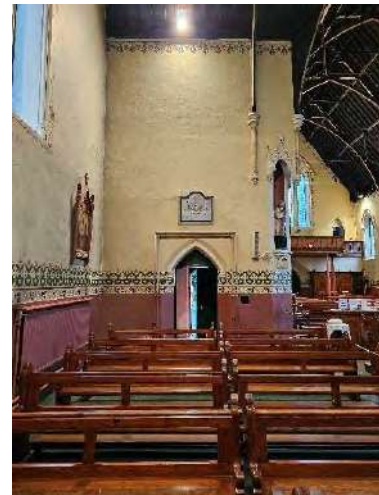
View south of door G-D04, east transept. Low level areas has been replastered and is in poor condition.

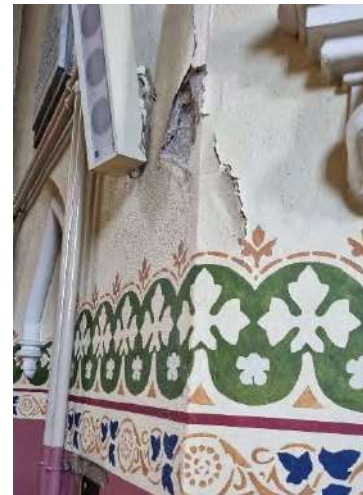
Section of cracked and boasted plaster at the junction between the nave and east transept.

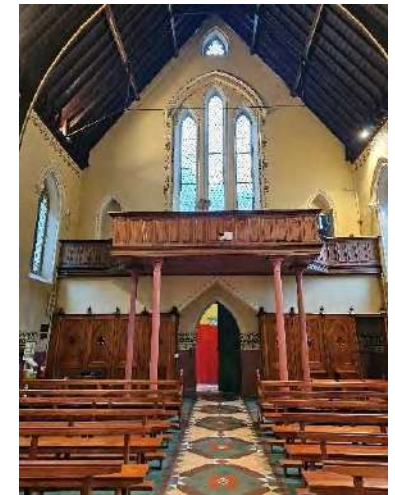
View of central aisle to the south, with choir balcony structure atop cast iron columns, understood to be original to the church.

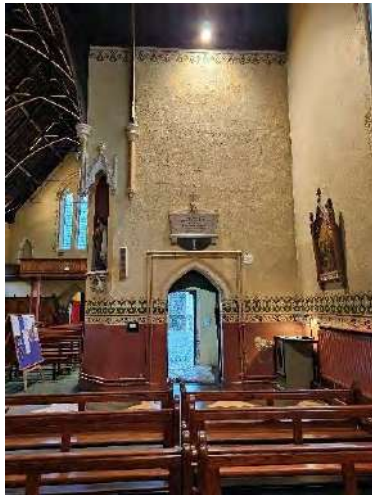
View south of door G-D12, west transept. Plasterwork in poor condition.

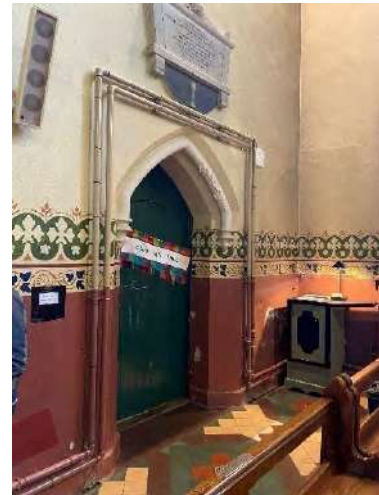
View of door G-D12 including piped services surrounding. Plasterwork in poor condition at low level.

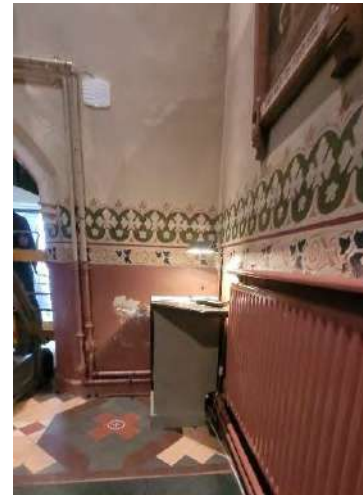
Area of deteriorated plaster finish to the rhs of door G-D12.

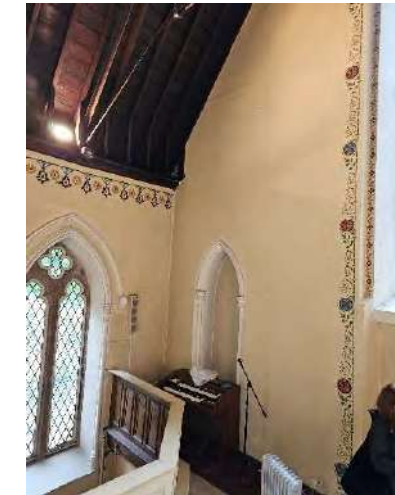
View to the lhs at balcony level including a niche mirroring the plasterwork detail of the door on the opposite side of the balcony. Random ashlar pattern finish with stencilling detail to window.

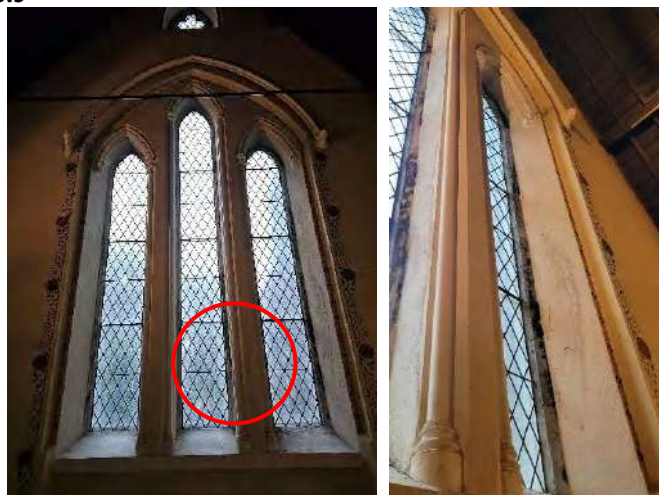
View of window W-G27 to choir balcony. Heavy mould growth to the stone mullions and water staining to painted reveals.

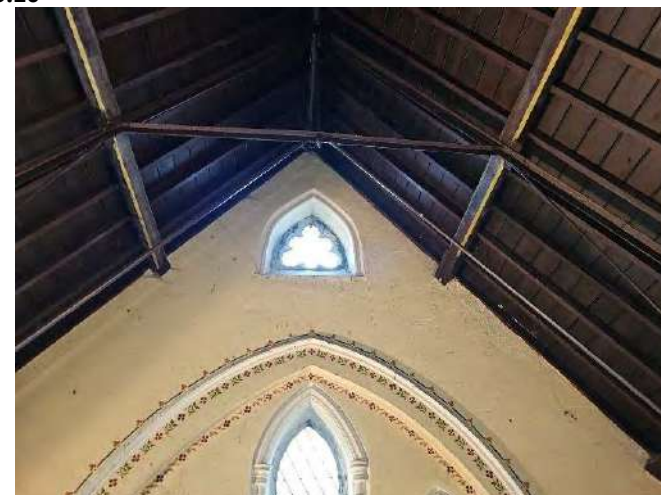
High level view above choir balcony of window W-F07.

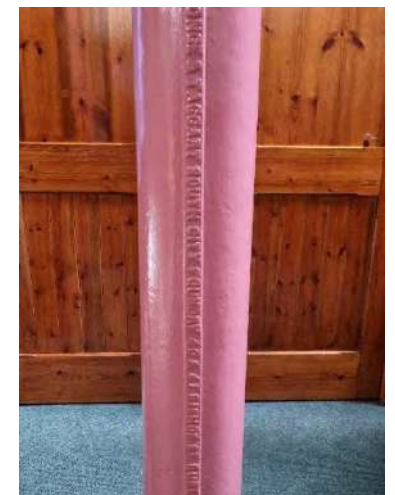
Detail of the cast iron columns supporting the choir balcony "Tonge & Taggart South City Foundry 40 & 41 Bishop St Dublin".

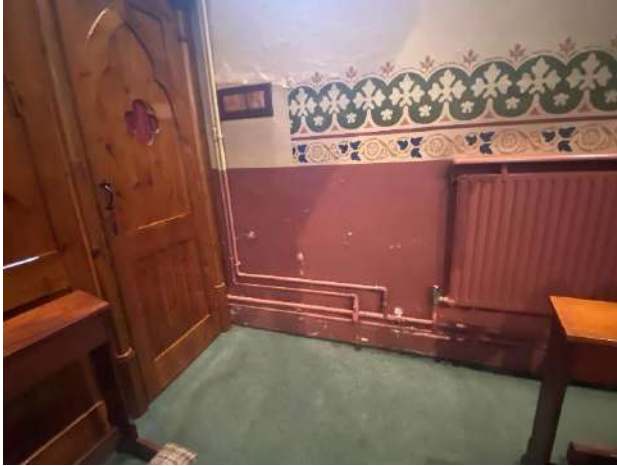
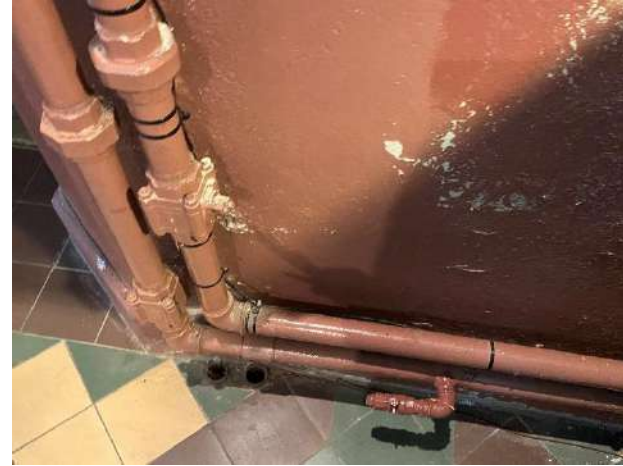
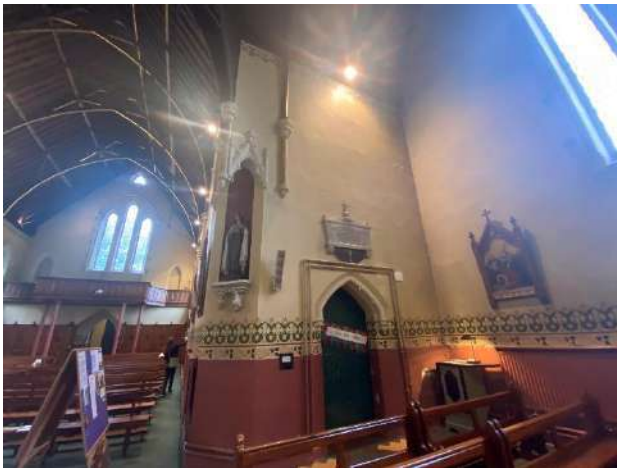
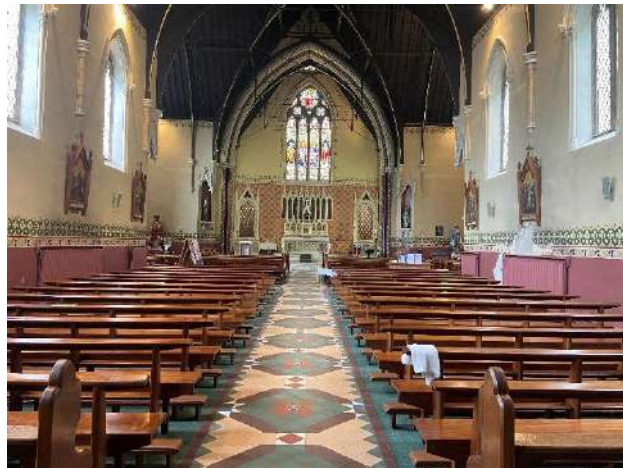
Existing Installation – Central Plant

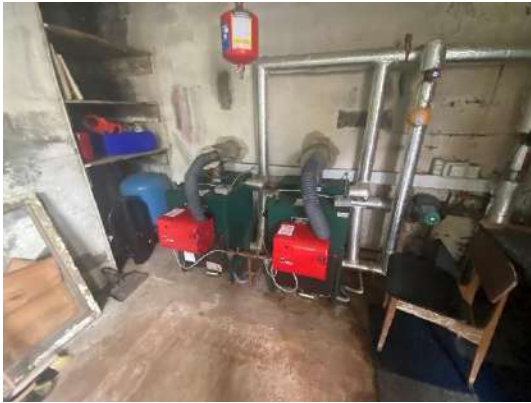
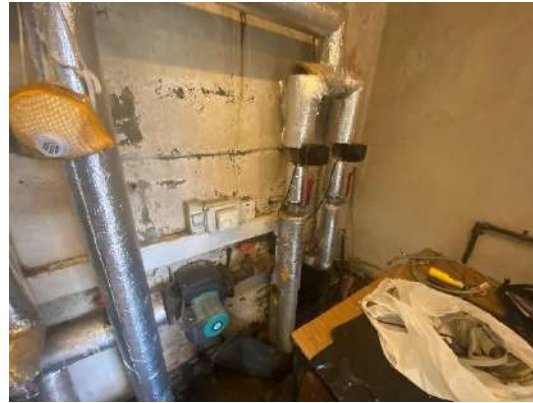
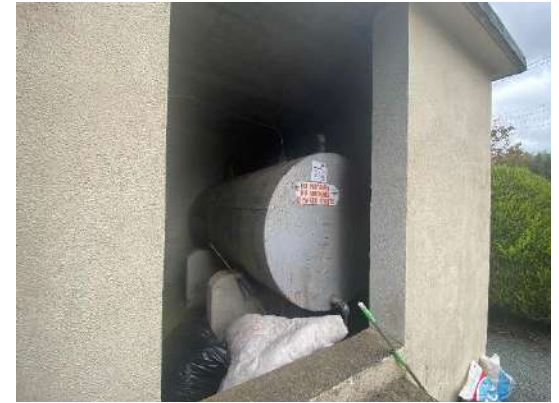
In general, the boiler plant is relatively new but the oil tank and older pipework sections are in poor condition.

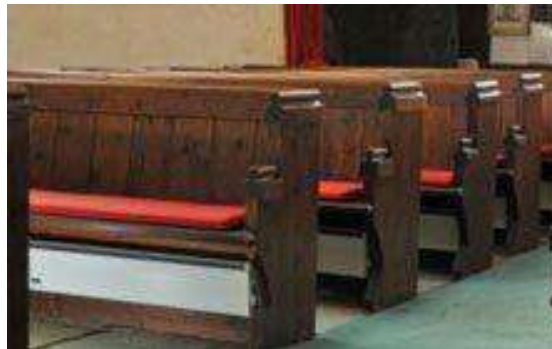
This system involves the installation of electric heaters under each seat in the Church. These heaters would be approximately 1000mm long and fixed to the timberwork of the seat. Heaters would be supplied by a cabling infrastructure which would require floor trunking approximately 250mm across x 50mm deep to be run on one side of each section of seating. A number of heaters would be required below each seat to cover the entire length of each seat. The system would be centrally controlled. The existing electrical infrastructure is inadequate and requires to be replaced before installation of this system. Ancillary areas would be heated by wall mounted electric panel heaters. This system has the advantages of localised heating of the congregation, but reduced flexibility in reorganisation of the seating in the Church.

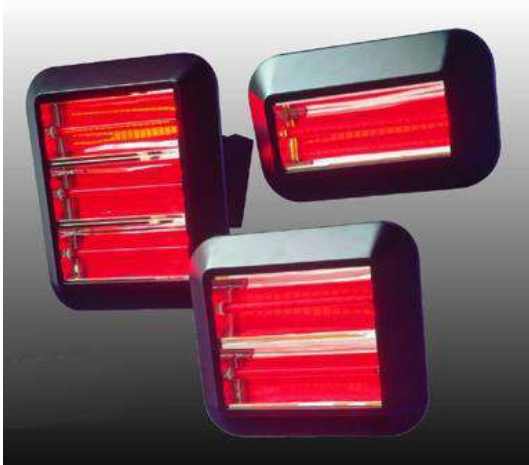
Other Heating Systems Examined & Discounted

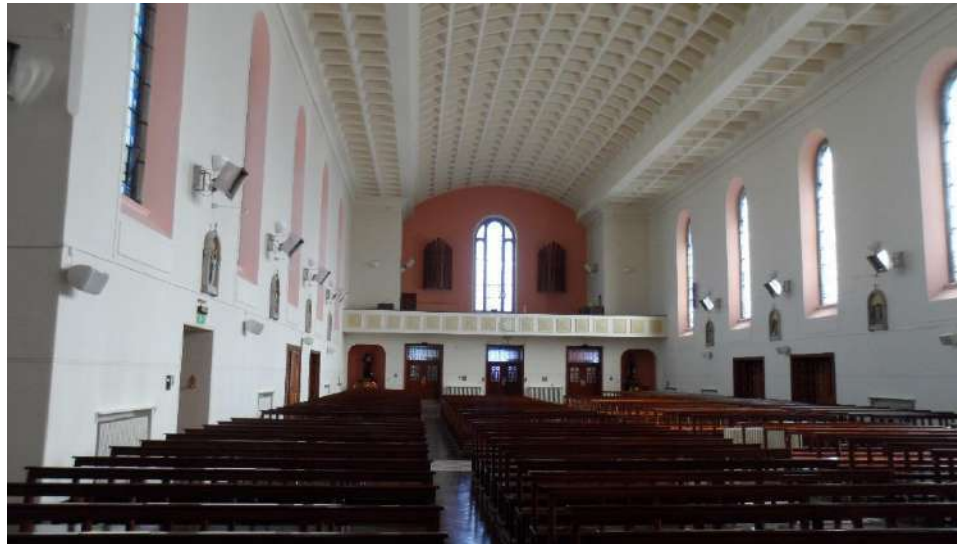
Other Heating Systems Examined & Discounted

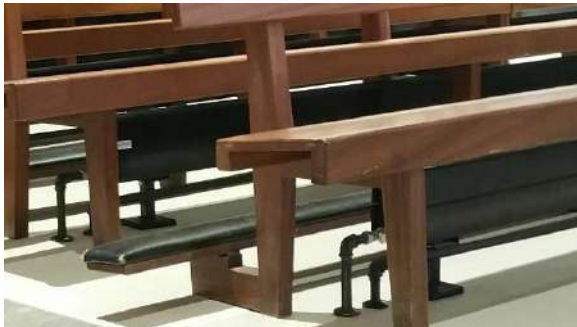
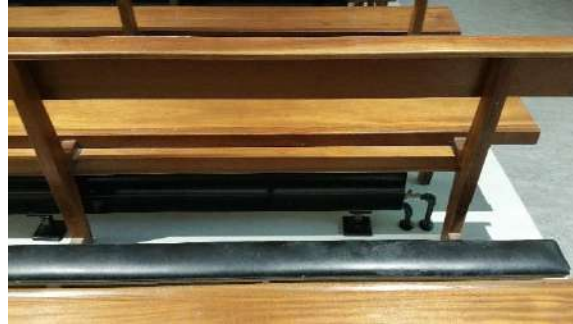
Recent Example: Church of the Sacred Heart, Yellow Walls, Malahide

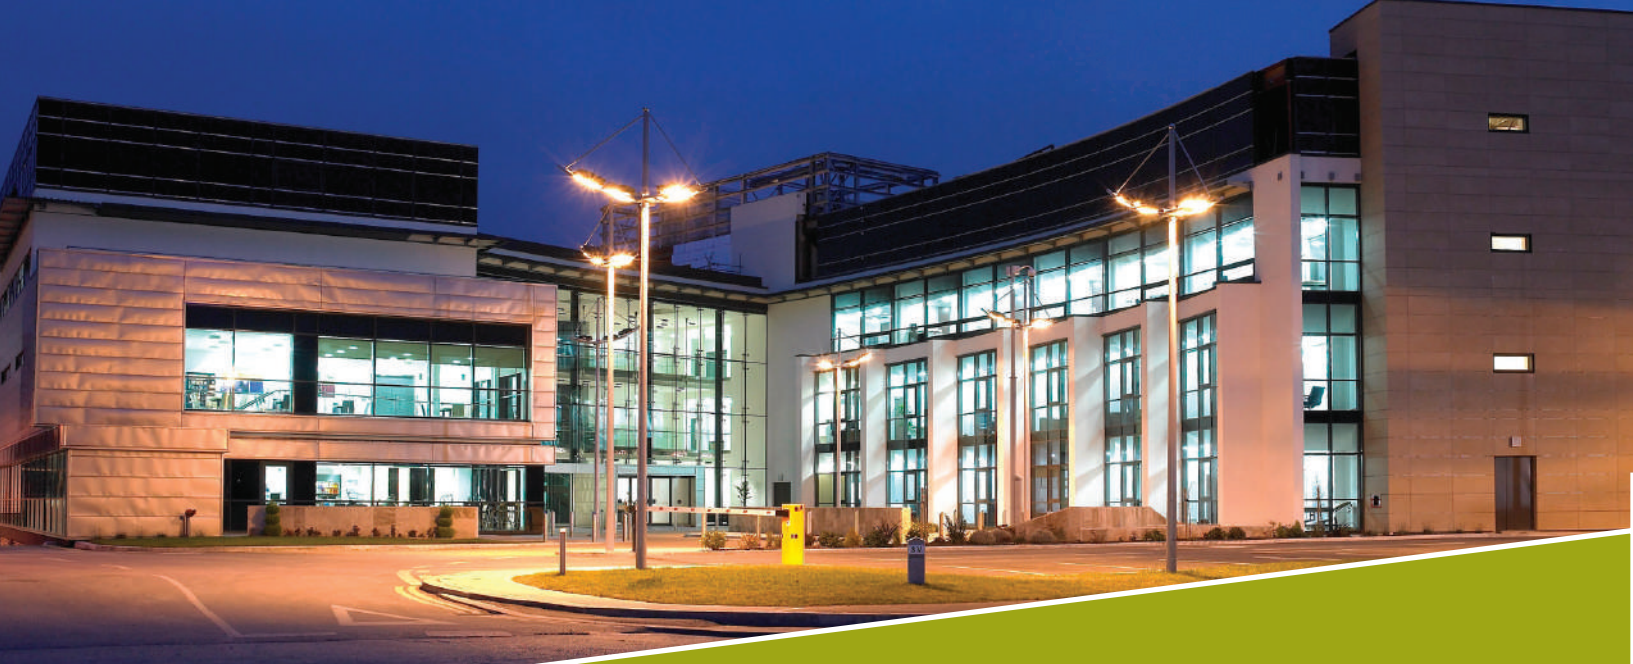
Brendan Merry & Partners
